Marine Survey Report

Pre-Purchase & Valuation

Date:	July 11, 2017
Reference No.:	MSE17XXX
Prepared for:	XXXXXXXX
Address:	XXXXXXXX
Phone:	XXX-XXX-XXXX
Fax:	XXX-XXX-XXXX
E-mail:	XXX@XXXX
Name of Owner:	XXXXXXXX

Location	Queen's Cove Marina, Victoria Harbour, Ontario	LOA	30', 6"
Name	XXXXXXXX	LWL	28', 7"
Type	Express cruiser	Beam	10', 6"
Manufacturer	Sea Ray Boats	Draft	2', 8"
Model	300 Sundancer	Displacement	9400lbs. approx.
Year of Mfg.	1992	Ballast	None
Registration	XX XXXXX	Rig	N/A

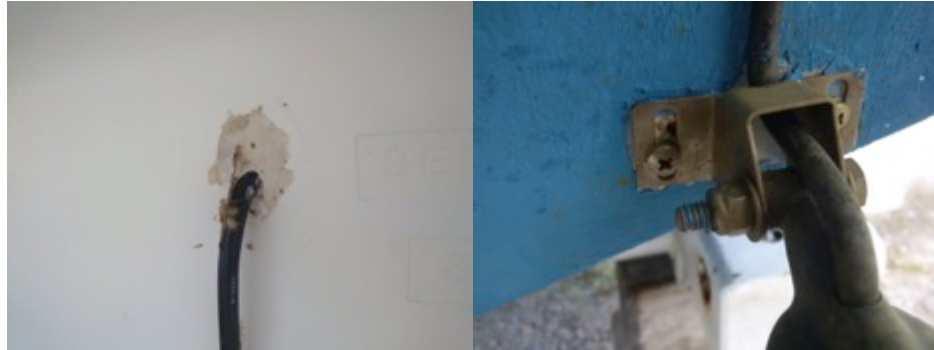
Transom – Intact and without evidence of elevated moisture levels. Depth transducer sealant well-weathered and the clam shell was found to be missing where the cable enters the transom. **See Comment 6**

6. The depth transducer on the transom should be rebedded at next haul out and a new clamshell installed where the cable enters the transom so as to minimize the possibility of water ingress to the fiberglass mat

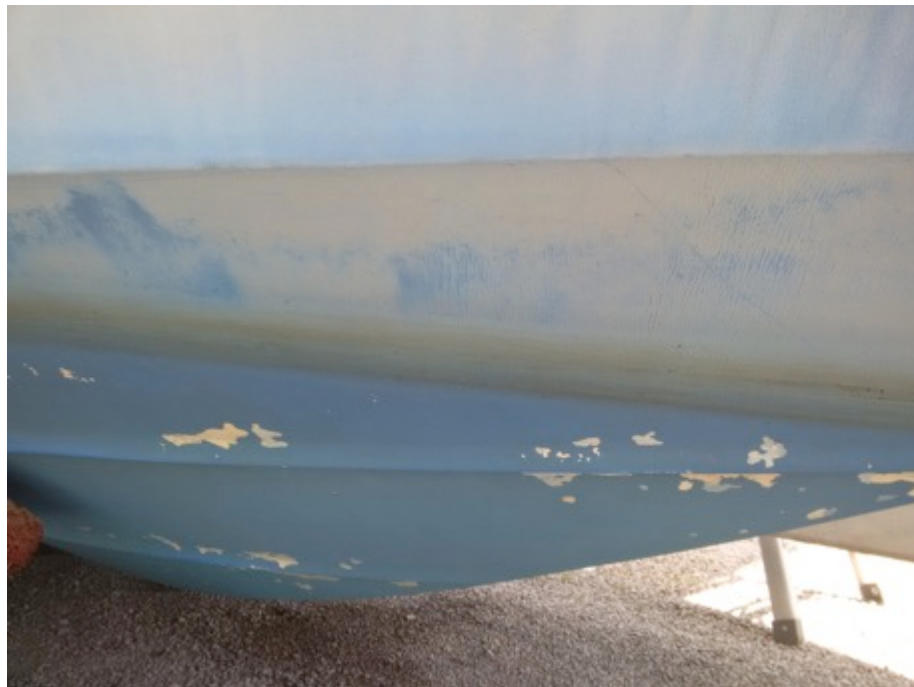
Bottom – Bottom found to be intact and without dullness to percussive sounding tests and no osmosis found where accessible. Vessel had just been hauled prior to the physical inspection, so moisture readings are inadmissible for the hull exterior. Ablative bottom paint found to be worn in many areas, and in some cases almost through to the FRP mat. **See Comment 17**

17. The ablative bottom paint is due for a recoat at the very least. A better option for the longevity of the hull and the finish is to have the bottom sandblasted and an epoxy finish applied prior to the application of the new ablative bottom paint. Your marina's service department can likely quote this work for you.

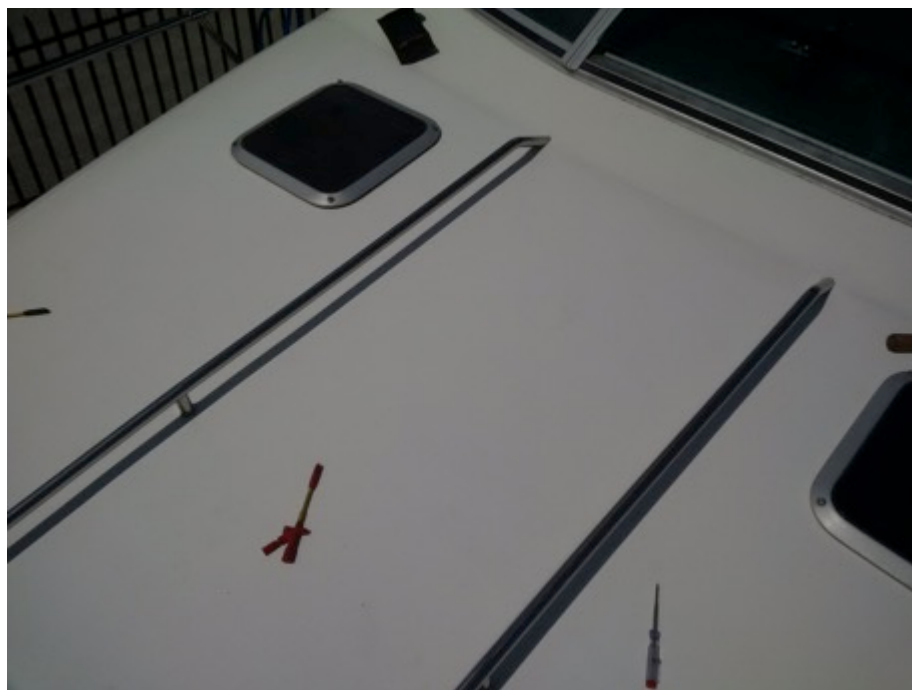
General Condition – Gelcoat oxidized and decals weathered. **See Comment 7.** Stress cracks across the deck slightly more prevalent than usual for a vessel of this age. The foredeck, in particular showed numerous stress cracks radiating from the grab rail stanchions and in several areas along the inboard aspect of the port and starboard bulwarks, often radiating from the bow rail stanchions. Some very high moisture levels were detected, along with significant dullness to percussive sounding tests, in the foredeck area (from the windshield base roughly 5ft forward and from the port side hatch to the starboard walkway) as depicted in the picture below (the locations of the tools mark the approximate perimeter of the affected area), as well as an area inboard of the starboard bulwark near the bow rail stanchion adjacent to the affected foredeck. **See Comment 1.**

Railings, Stanchions, Lifelines – The starboard bow rail stanchions were found to be loosening up. In particular, the starboard aft-most stanchion presented with significant mobility. Excessive sealant use around that stanchion is an indication it has been mobile for some time. Elevated moisture levels around this area provide some indication that underlying fiberglass repair may be indicated. **See Comment 1**

1. Moisture content in the foredeck and starboard walkway is significant and, if not repaired, the structural integrity of the foredeck will be compromised and the value of the boat affected significantly. Further investigation is necessary to determine the extent of required repairs, but the core is clearly soft and the moisture undoubtedly extends beyond the areas that are soft. Thermal imaging could be considered to help determine the size and subsequent cost of repairs.

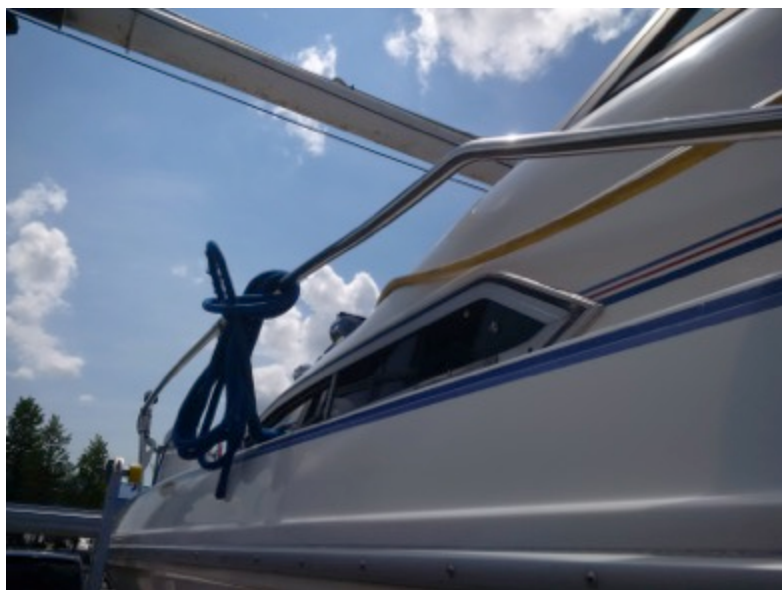
The aft section of the port side bow rail is bent. **See Comment 16**

16. The port side of the bow rail does not pose a safety risk but is clearly damaged (likely from impact). It is possible to have stainless rails repaired.

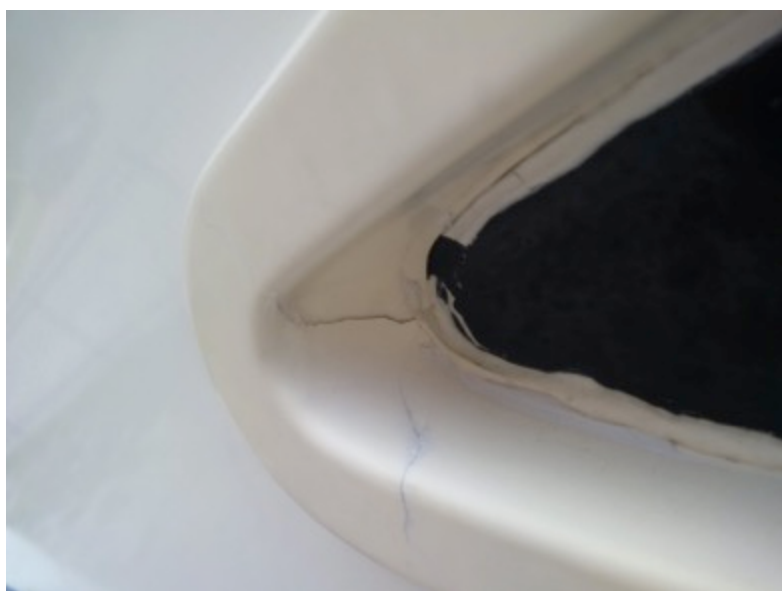
Windshield, Portlights – Windshield and wipers intact and serviceable. Windshield power-operated vent found to be operational. Forward V-berth portlights found to have cracked frames and crazed lexan window. **See Comment 2**

Headliners/Bulkheads/Cabinetry – Bulkheads and joinery all found to be in good condition for the age of the vessel. Some water staining evident below portlights in forward V-berth, indicating that water seepage has already occurred. **See Comment 2**

2. The V-berth portlights should be replaced. There are a number of options available in different sizes, some of which open and have screens to improve ventilation of the V-berth

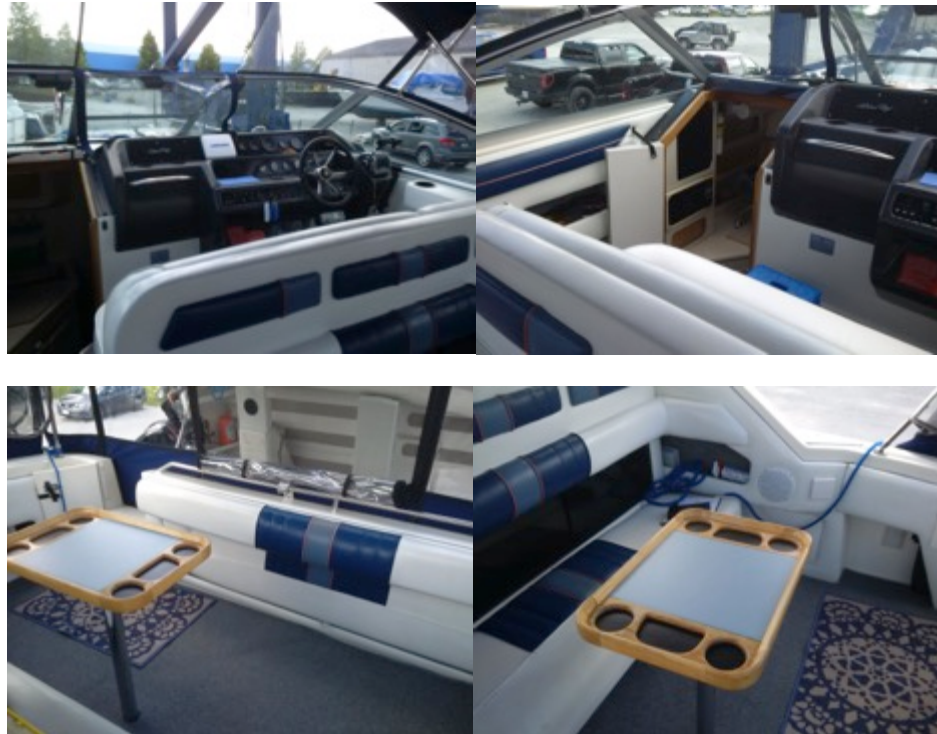
Express cruiser style cockpit amidships with open access to aft deck area and back-to-back bench seating at helm. Helm bench seat vinyl appeared updated. Bench seat facing aft deck presented with vinyl that was more worn, with some of the stitching coming apart. **See Comment 10.**

9. The rub rail should be rebedded at next haul-out and the fasteners properly seated
10. The aft cockpit bench seat is due for an upgrade as the existing vinyl is weathered to a point where it will be difficult to repair

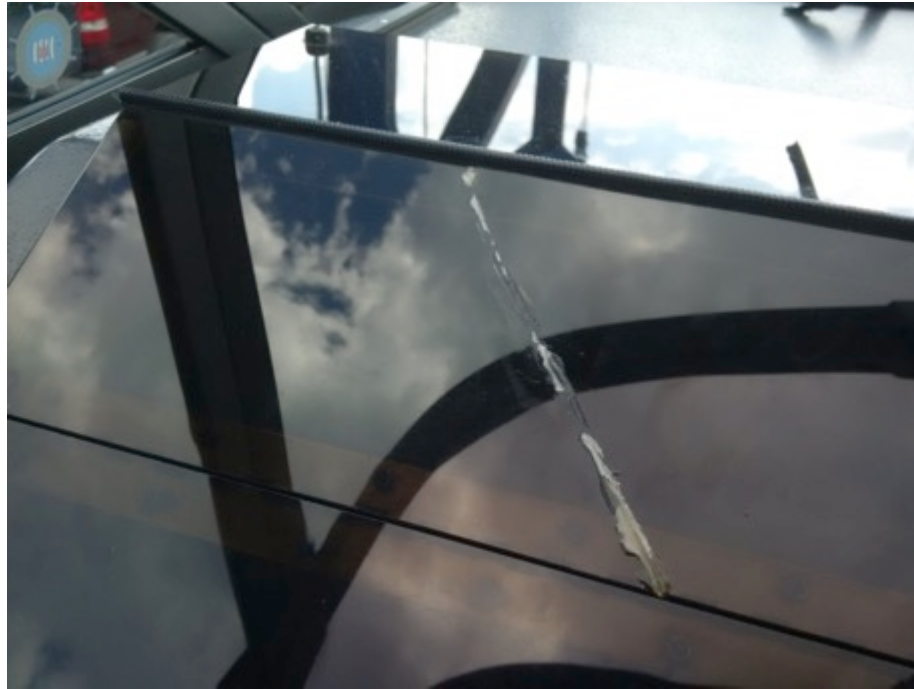
A transom gate provides access to swim platform and latches securely. Forward port area of cockpit provides access to companionway steps down to main cabin. Companionway hatch secures properly but the plexiglass top is cracked in two places. **See Comment 11**

11. The companionway hatch top plexiglass seems solid but the cracks are unsightly. It may be nigh impossible to find a direct replacement for these pieces

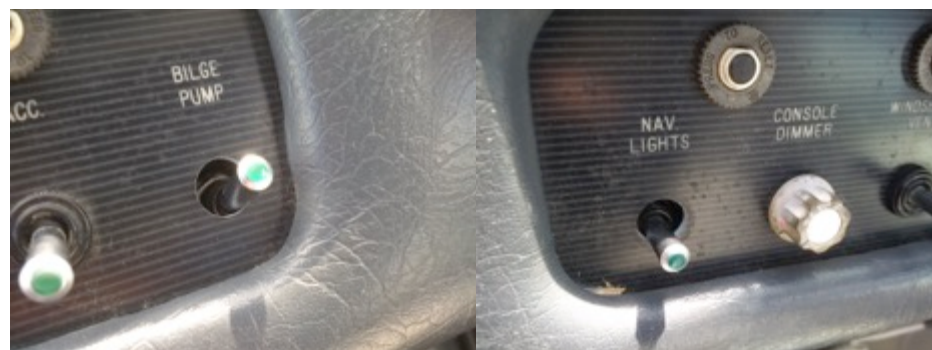
Cables/Wiring/Connections/Fixtures – All cables, connections and fixture found to be compliant, with the exception of two switches that were found broken at the helm (one for the bilge pumps and the other for the navigation lights). **See Comment 13**

12. The anodes on the outdrives and trim tabs are pitted and will likely be due for replacement before launch next season
13. The broken switches at the helm need to be replaced. They both work electrically, but the integrity of the switch body is compromised. It is likely that all of the switches are due to be upgraded soon

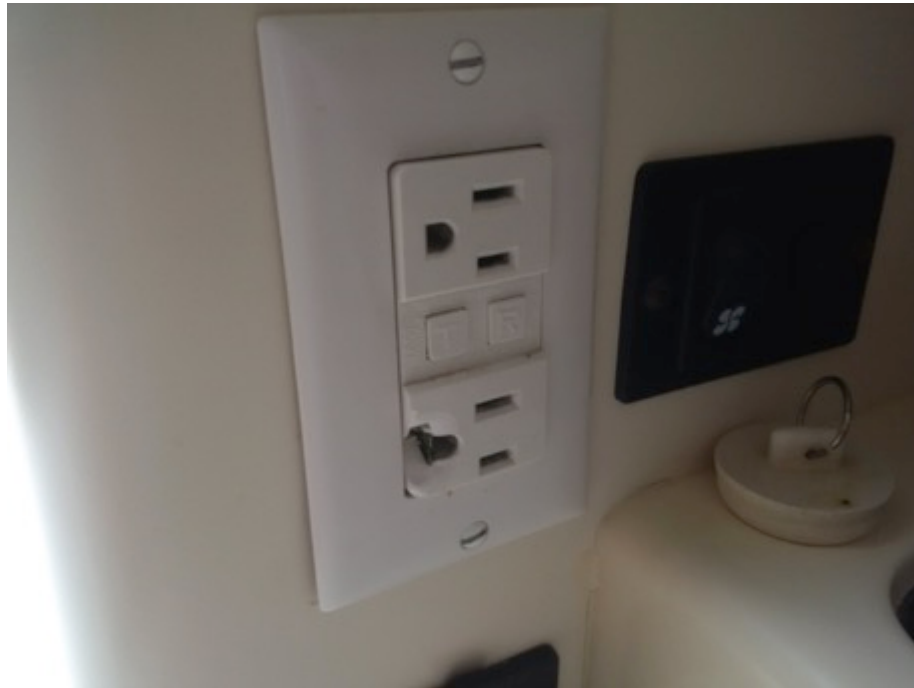
Outlets – GFCI outlet in galley presented with broken plastic housing. **See Comment 3**

3. The GFCI outlet in the galley should be replaced prior to next use as the plastic housing is broken
4. The 150psi pressure relief valve on the hot water tank is not suitable for a marine pressurized water system. As the only pressure relief valve in the system, ABYC standards require the valve to vent at no more than 50% higher than the normal operating pressure of the system. 75psi pressure relief valves are available from marine chandleries

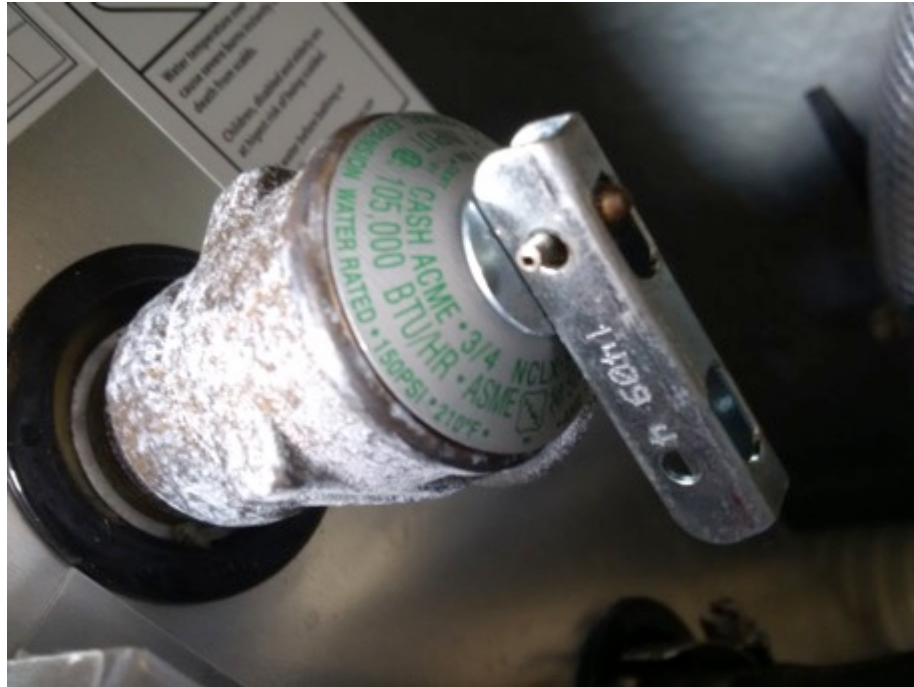
Water Heater – Newer Kuuma 6 gal US hot water tank installed in port aft corner of engine compartment below aft deck. Pressure relief valve rated at 150psi. **See Comment 4**

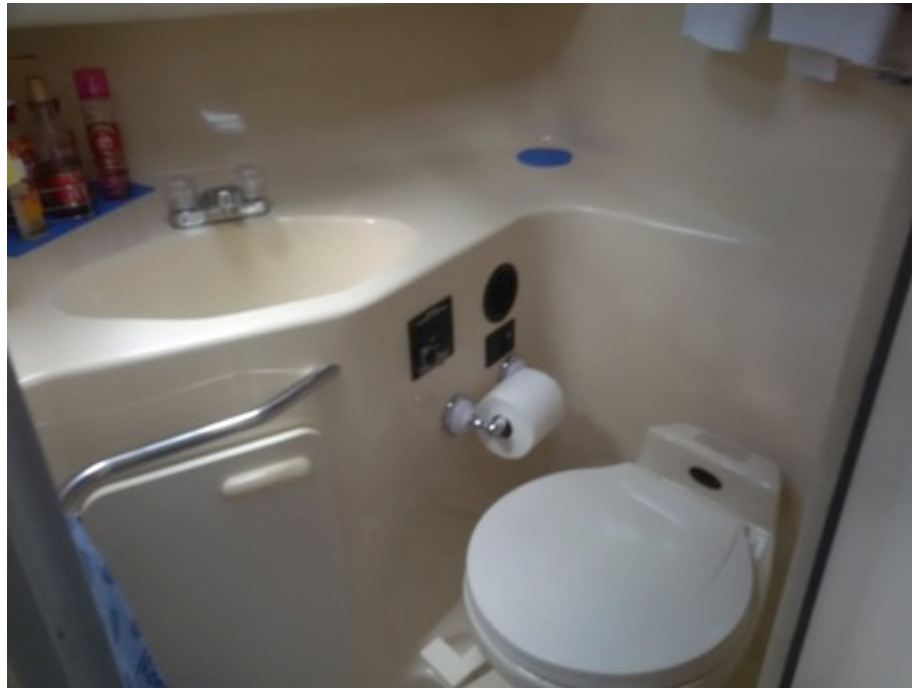
Heads – Single head located at port side of main cabin amidships. All fixtures appeared in serviceable condition. Head found to be equipped with sink, vanity and Vacuflush toilet. The sanitation pump runs continuously when the system is powered up. **See Comment 14**

14. The sanitation pump should be further investigated and repaired so that it works correctly
15. The sanitation hoses are due for replacement. Permeated hoses will cause lingering sanitation odours onboard. Some consideration could be given to installing a holding tank charcoal vent filter when the sanitation hoses are replaced, which will also help control odours when flushing the head
