Condition & Valuation Marine Survey Report of

1987 Carver 32 Montego

Timothy J. S. Martin

SAMS Accredited Marine Surveyor® #1360

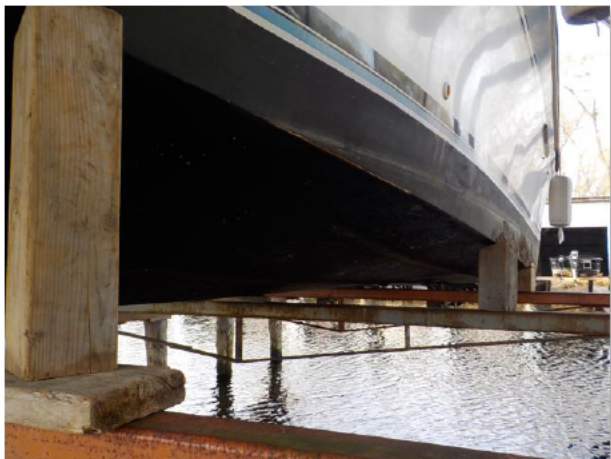
FIGURE 13 - HULL BOTTOM

F480	<p>Finding</p> <p>Marine growth on bottom paint below the waterline.</p>
R480	<p>Recommendation</p> <p>Bottom wash to permit a more thorough bottom inspection.</p>

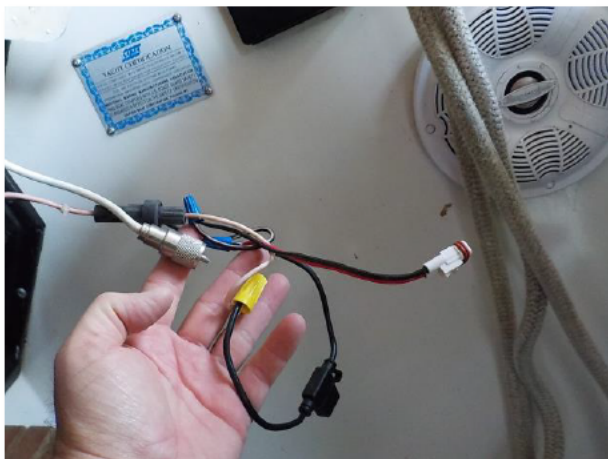
FIGURE 33 – WIRE NUTS OBSERVED AT VHF CONNECTIONS IN COCKPIT

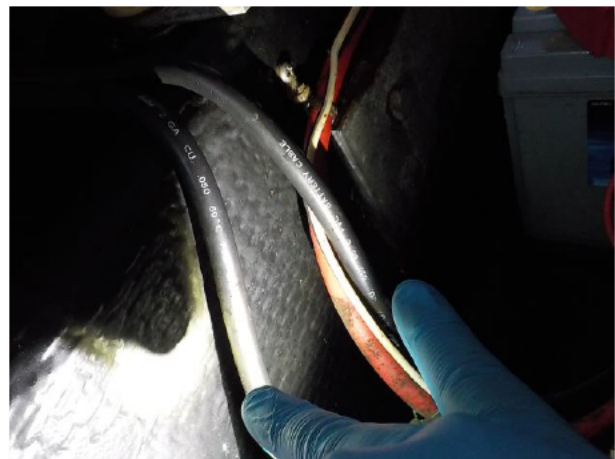
FIGURE 34 – NON-APPROVED WIRE TYPE OBSERVED AT BATTERY CABLES IN THE ENGINE SPACE

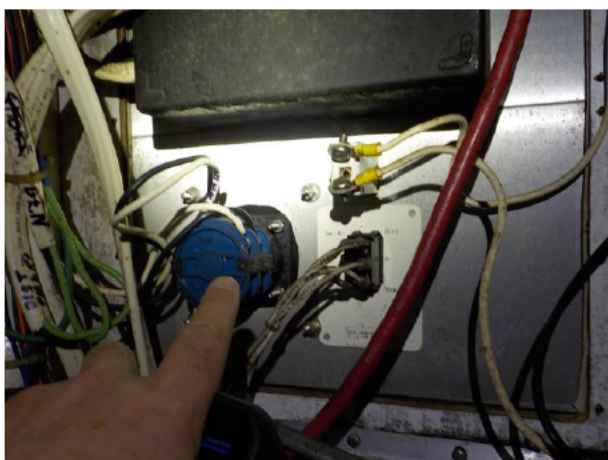
FIGURE 35 – SHIP/SHORE SWITCH CONNECTION EXPOSED IN HEAD CABINET

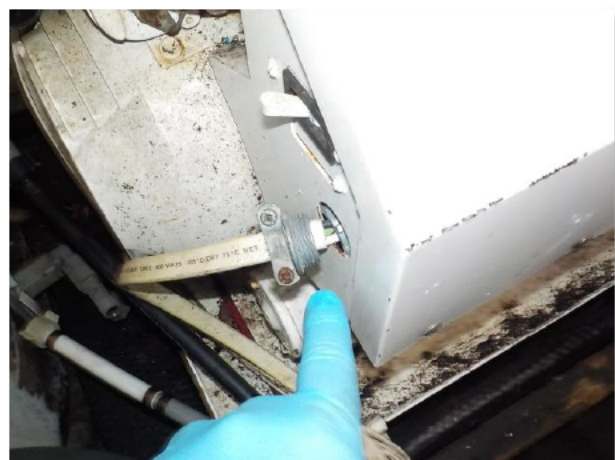
FIGURE 36 – UNSUPPORTED WIRE OBSERVED ON GENERATOR ENCLOSURE IN THE ENGINE SPACE

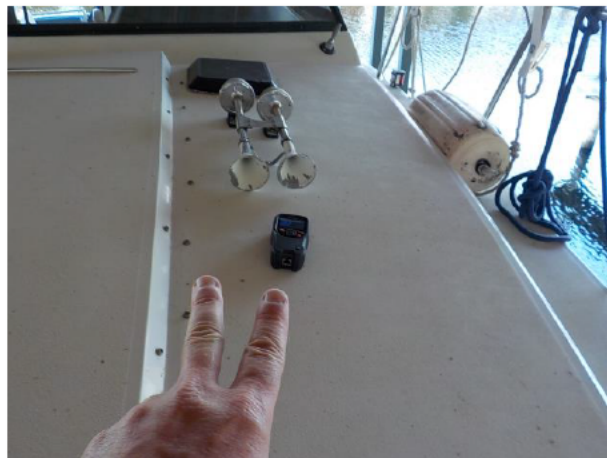
FIGURE 38 – ELEVATED MOISTURE OBSERVED ON FOREDECK

R406	<p>Recommendation</p> <p>Moisture in the affected area(s) should be monitored and further investigated as necessary. Consideration could be given to invasive testing, such as core samples, to determine condition of core and fibreglass substrate. The surveyor has no immediate structural concerns in the affected area(s) of this vessel; however, it should be noted that repairs will very likely be necessary in the future. Exact timing of the necessity of any future repairs is not possible within the scope of non-invasive testing undertaken as a part of this survey.</p>
F406	<p>Finding</p> <p>Moderately elevated relative moisture readings with bright soundings were obtained in the following areas:</p> <ul style="list-style-type: none"> • Foredeck, port side, forward of horn
R406	<p>Recommendation</p> <p>Moisture in the affected area(s) should be monitored and further investigated as necessary. Consideration could be given to invasive testing, such as core samples, to determine condition of core and fibreglass substrate. The surveyor has no immediate structural concerns in the affected area(s) of this vessel; however, it should be noted that repairs will very likely be necessary in the future. Exact timing of the necessity of any future repairs is not possible within the scope of non-invasive testing undertaken as a part of this survey.</p>
