**Condition & Valuation Marine Survey Report of**

██████████  
**1982 Tayana Vancouver 42**

Sophie Foster, M.Eng  
Staff Surveyor/Naval Architect  
Transport Canada Appointed Tonnage Measurer <24m

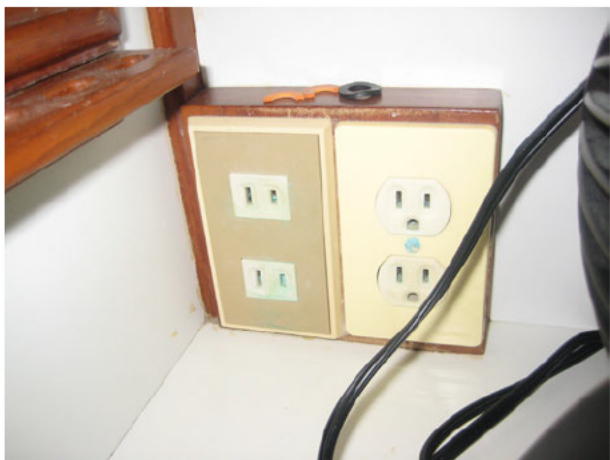
FIGURE 53 – NON-GFCI RECEPTACLES IN HEAD

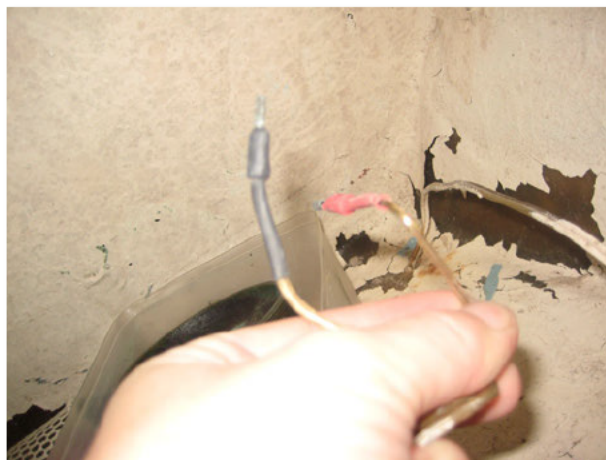
FIGURE 54 – BARE WIRE ENDS IN INSPECTION PORT AFT COCKPIT

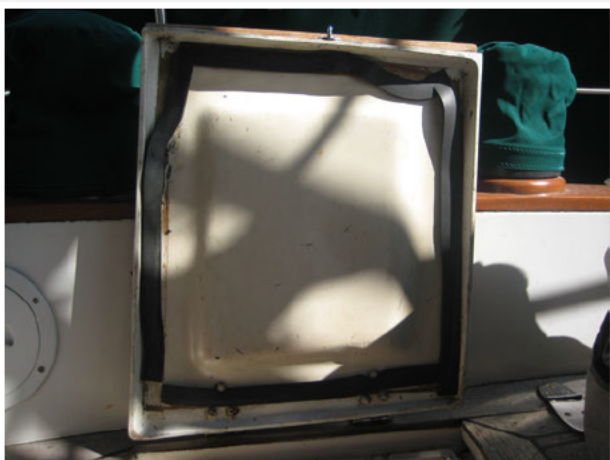
FIGURE 55 – LOOSE SEAL ON PROPANE LOCKER LID

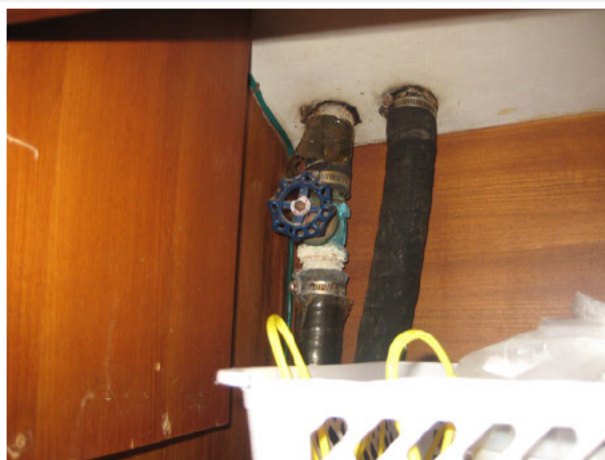
<b>F-10</b>	<b>Finding:</b> Gate valve installed in waste pump out hose observed to be corroded. <b>Recommendation:</b> Replace gate valve or remove and reconfigure pump out hose arrangement.
<b>F-11</b>	<b>Finding:</b> Sliding plexiglass top at companionway observed to be crazed. <b>Recommendation:</b> Consider replacement of plexiglass.
<b>F-12</b>	<b>Finding:</b> No recertification tags fitted to portable fire extinguishers in cabin. Recertification tags fitted to portable fire extinguishers in cockpit show date of last service as 2009. <b>Recommendation:</b> Fire extinguishers should be recertified and tagged or replaced, in the interest of maintaining the extinguishers in serviceable condition.

FIGURE 56 – CORROSION AT GATE VALVE IN WASTE PUMP OUT HOSE
