**Condition & Valuation Marine Survey Report of**

**1988 Kha Shing Overseas 40**

Timothy J. S. Martin

SAMS Accredited Marine Surveyor® #1360

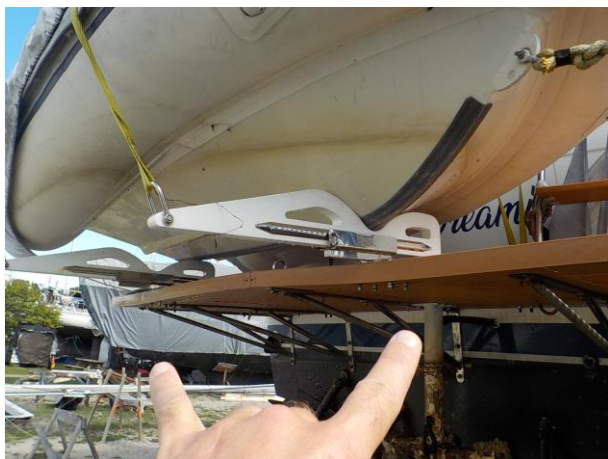
FIGURE 41 – DISTORTION OF AFT PLATFORM

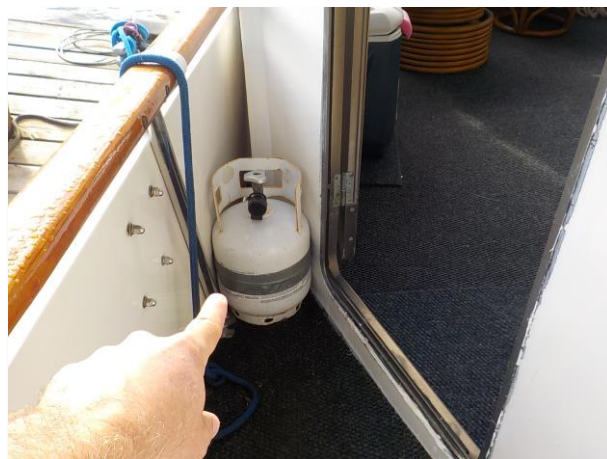
FIGURE 42 – UNSECURED LPG CYLINDER

3. An unsecured 10lb. steel LPG (propane) cylinder was observed stowed at the starboard side deck access door. Remove LPG cylinder from unsecured storage, to comply with Sections 604 & 721 of the Small Vessel Regulations, Section 1.7.6 of ABYC Standard A-1.

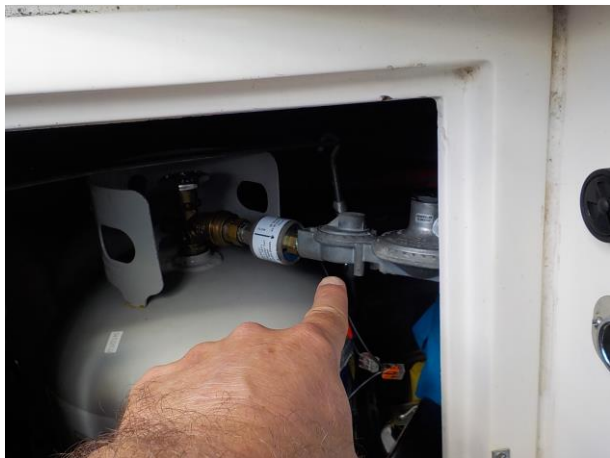
be original (and some not accessible for inspection). In addition, using the under bridge apron storage as a propane locker is not suitable, as the locker is full of other gear, has insufficient venting and contains a large number of electrical components that are not ignition protected. In the opinion of the attending surveyor, the propane system should be completely removed from the vessel. Alternatively, the propane system could be update and relocated or the locker modified to meet applicable standards for safety. At a minimum, the system should be inspected by qualified technician, in order to ensure safe operation and compliance with Sections 604 & 721 of the Small Vessel Regulations and ABYC Standard A-1. The system should not be used until repairs have been satisfactorily completed. In addition, any electrical components in the propane locker should be confirmed as compliant with ignition protection requirements in Sections 608 & 731 of the Small Vessel Regulations, Section 8.4 of TP1332E Construction Standards for Small Vessels and Section 11.5 of ABYC E-11 (or equivalent SAE J1171, UL1500, C1500, ISO 8846 or ISO 8-8846 ignition protection standards), or replaced with a model that is Ignition Protected, or relocated outside of the propane storage compartment.

FIGURE 43 – SINGLE STAGE REGULATOR IN UNSUITABLE PROPANE LOCKER

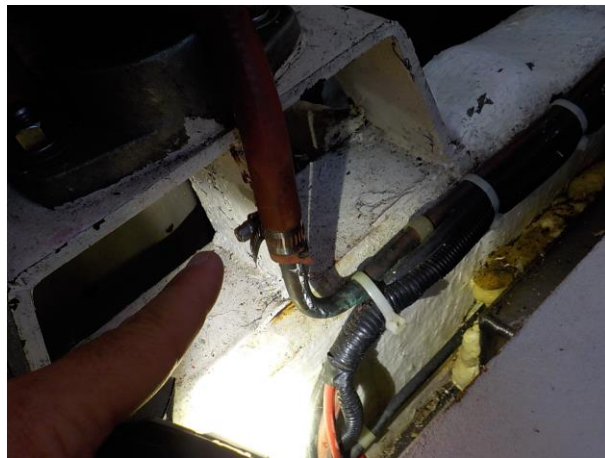
FIGURE 44 – IMPROPER FUEL HOSE CONNECTION AT PORT MAIN ENGINE

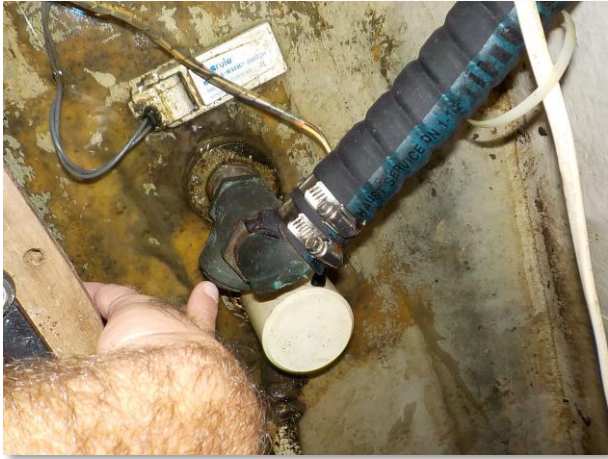
FIGURE 45 - NO SEACOCK ON SANITATION SYSTEM OVERBOARD DISCHARGE      FIGURE 46 - EXTENSION CORD LAYING IN BILGE

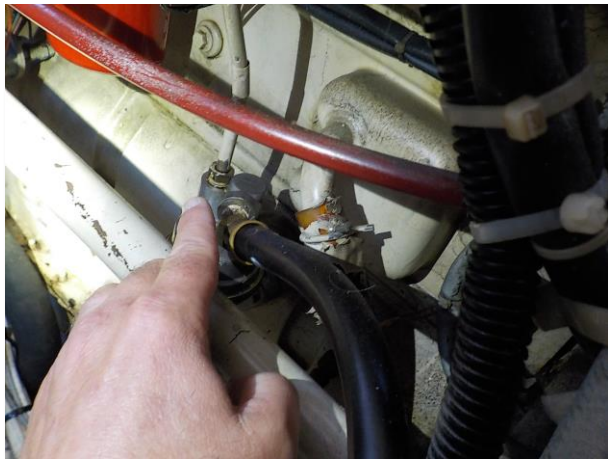
13. A film of fuel was observed around the fittings of the mechanical fuel pump fitted to the port side of the starboard main engine block. Prompt further investigation recommended to determine and correct the cause, to prevent contamination of bilge water.

FIGURE 47 - WEEPING FUEL PUMP FITTING AT STARBOARD MAIN ENGINE      FIGURE 48 - UNJACKETED TURBOCHARGERS IN ENGINE SPACE

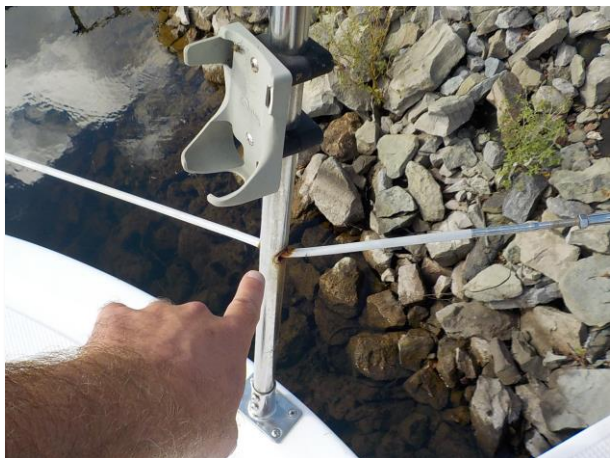
15. Significant corrosion staining was observed at the lifeline fittings at the bow rail, suggestive of some crevice corrosion with potential for deterioration of hardware. Recommend prompt further inspection of lifelines, fittings and swages, to prevent unexpected failure.
16. Damage was observed at the port side deck wooden cap rail, and the cap rail has been temporarily repaired using flat bar and screws. This configuration is unlikely to last long and should not be considered a permanent repair. Railings are required to withstand a force of 400lbs. in any direction. Recommend prompt repair/replacement of the damaged wooden cap rail.

FIGURE 49 – LIFELINE CORROSION AT THE BOW RAIL

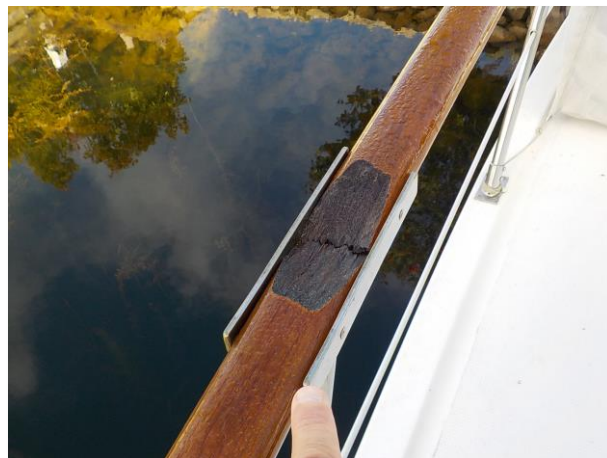
FIGURE 50 – WOODEN CAP RAIL DAMAGE

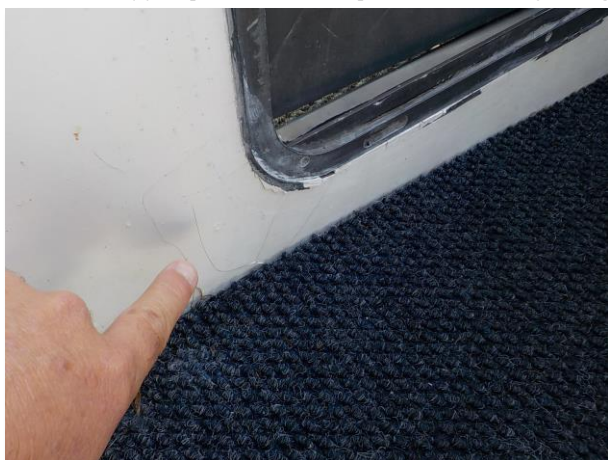
FIGURE 51 – DETERIORATED AREA AROUND SIDE DECK ACCESS DOORS

Moisture in the cabin trunk and bow pulpit should be further investigated as necessary to help determine urgency and best course of action for repair. Indications of core deterioration are present and invasive testing, such as core sampling, is recommended. While in the opinion of the surveyor complete structural failure is unlikely in the affected area(s), repairs will be required soon, likely at significant cost.

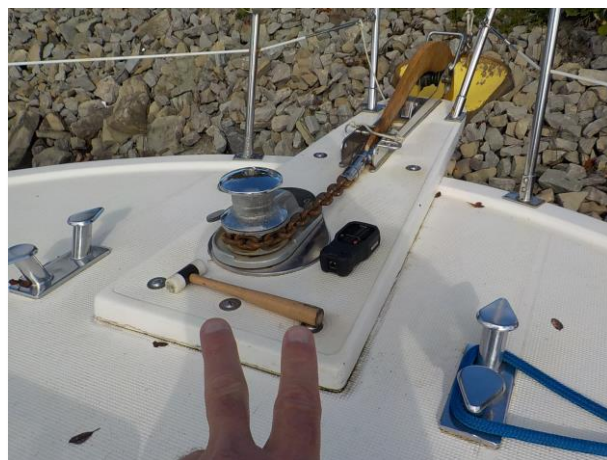
FIGURE 52 – DETERIORATED BOW PULPIT

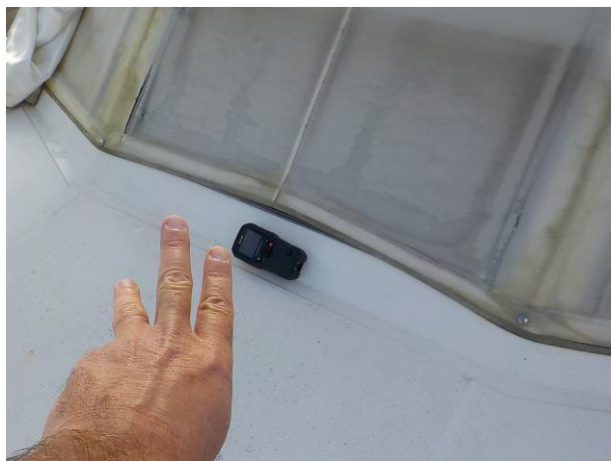
FIGURE 53 – ELEVATED MOISTURE IN FOREDECK

Moisture in the foredeck, forward weather deck, and in the aft deck atop the aft cabin, should be monitored and further investigated as necessary. Consideration could be given to invasive testing, such as core samples, to determine condition of core and fibreglass substrate. The surveyor has no immediate structural concerns in the affected area(s) of this vessel; however, it should be noted that repairs will very likely be necessary in the future. Exact timing of the necessity of any future repairs is not possible within the scope of non-invasive testing undertaken as a part of this survey.

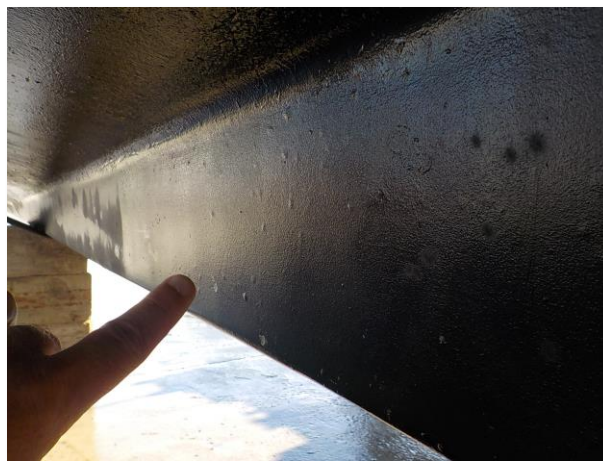
FIGURE 54 – NON-STRUCTURAL BLISTERS ON KEEL

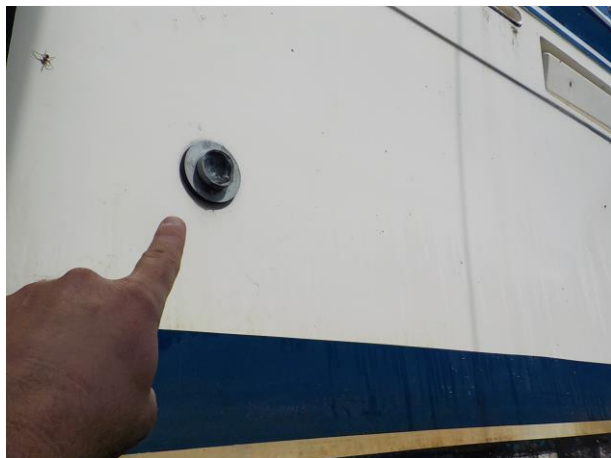
46. A stainless through-hull fitting along the starboard topsides amidships above the waterline (possibly the original generator exhaust discharge fitting) was found to have the hose disconnected inside the engine space and the exterior opening filled in with silicone sealant. While the silicone appears intact, the fitting is relatively close to the waterline. It is recommended that this fitting be properly capped or removed (and the fibreglass repaired) to prevent water ingress to the engine space in the event of failure of the silicone plug.

FIGURE 55 – SILICONE FILLED THROUGH-HULL STARBOARD TOPSIDES

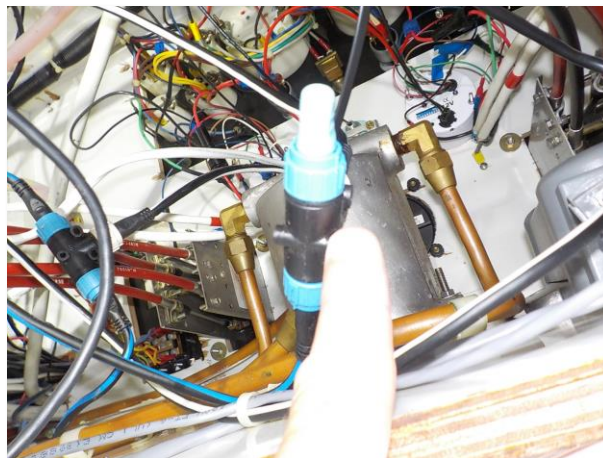
FIGURE 56 – UNSECURED NMEA NETWORK CONNECTIONS BELOW LOWER HELM
