Condition & Valuation Marine Survey Report of

2014 Tes 28 Magnam

Sophie Foster, M.Eng
Staff Surveyor/Naval Architect
Transport Canada Appointed Tonnage Measurer <24m

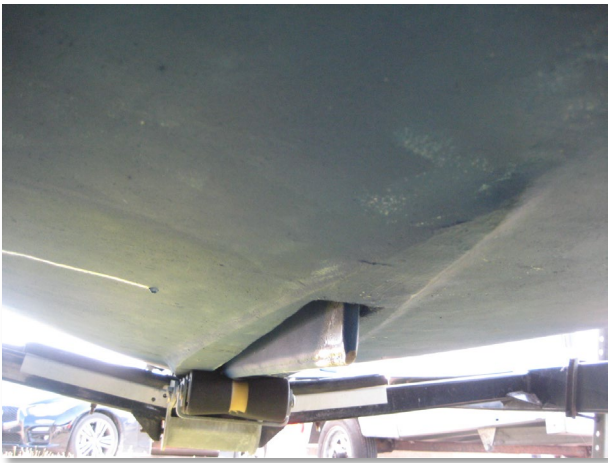
FIGURE 11 – HULL BOTTOM VIEW

Bright soundings were audible to percussive sounding tests throughout the hull bottom, topsides, transom, decks and accessible structure below deck. Some moisture readings taken across the hull bottom and topsides produced slightly elevated moisture levels. The readings were sporadic and isolated in nature, and just inside the range to be considered "slightly elevated", per the definition given in Section 2.4. Therefore, the attending surveyor considers the hull to be dry.

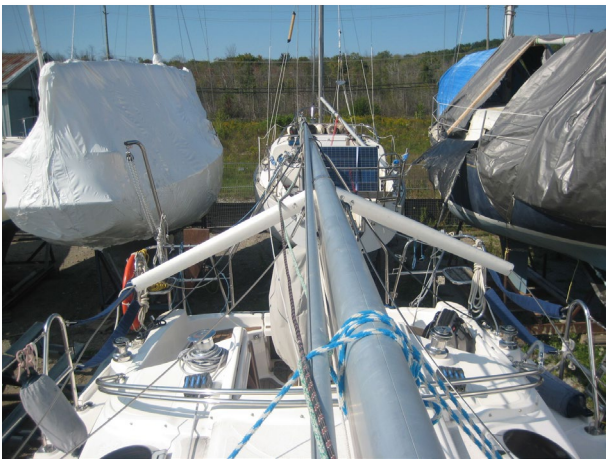
FIGURE 15 – MAST INSPECTED ON DECK

1x19 wires appeared intact and securely fastened, without any broken strands visible. Stainless fittings appeared intact, straight and without visible cracks where accessible for inspection. Rigging appeared to be properly tuned and serviceable during sea trial.

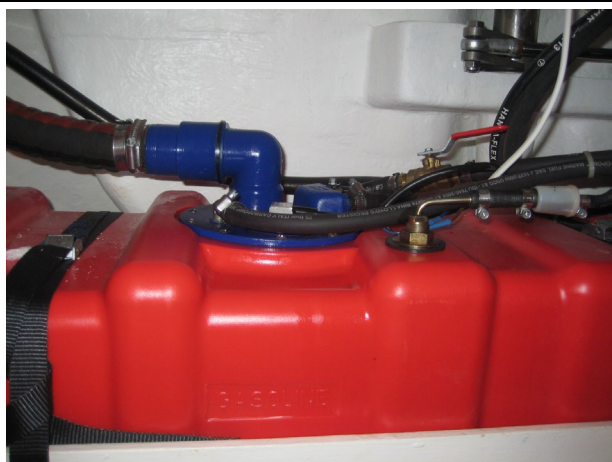
FIGURE 25 – FUEL TANK

Tank appeared to be intact and securely fastened to the vessel. Tank label observed and appeared to be compliant. It was noted that the fuel tank is labelled gasoline but is reported to be the original installation by the manufacturer. No leaks were sighted at the tank or tank fittings. Deck fill fitting appeared to be intact, securely fastened and serviceable. Venting appeared intact where accessible for inspection. Plastic fuel tank does not require grounding. No deck fill grounding sighted. Fuel valves appeared serviceable and without leaks or weeping at valve bodies or fittings. Fuel valves were cycled and confirmed operational. Fuel filters secured to the vessel and appeared serviceable. No leaks sighted at fuel filters or related fittings. Compliant hoses sighted for fuel fill, vent and supply, no dates sighted. Fuel hoses appeared intact and serviceable where

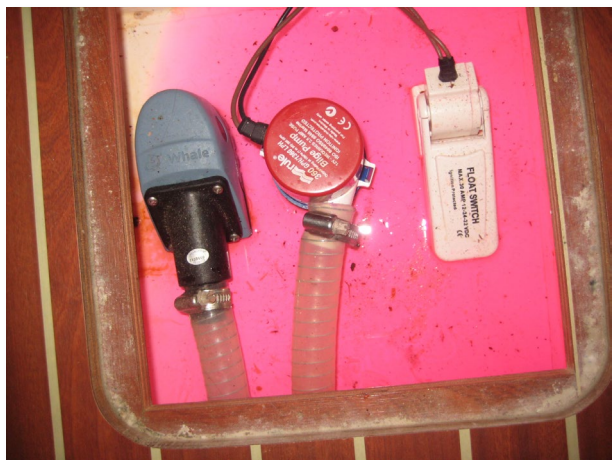
FIGURE 33 – BILGE PUMPS FITTED BELOW CABIN SOLE

Accessible bilge pumps, float switches, hoses and connections appeared intact, securely fastened and serviceable. Bilge pumps powered up and sounded operational, though not tested with dynamic load due to the absence of sufficient bilge water on the day of survey.

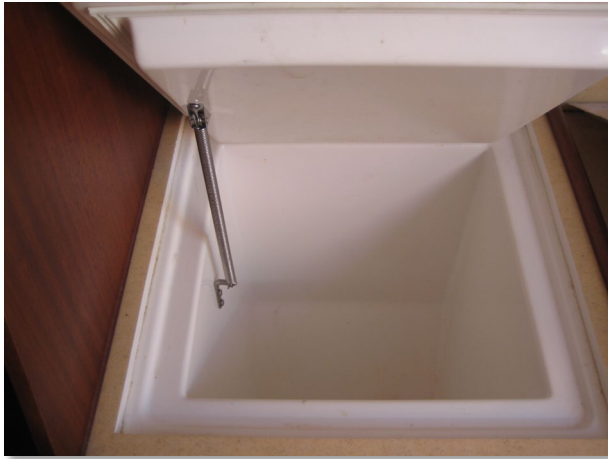
FIGURE 43 – CHEST TYPE REFRIGERATOR IN GALLEY

Refrigeration appliances appear to be intact and serviceable. Refrigeration units appear to be properly secured to the vessel structure. Refrigeration appliance powered up during dockside testing but did not appear to be cooling correctly.

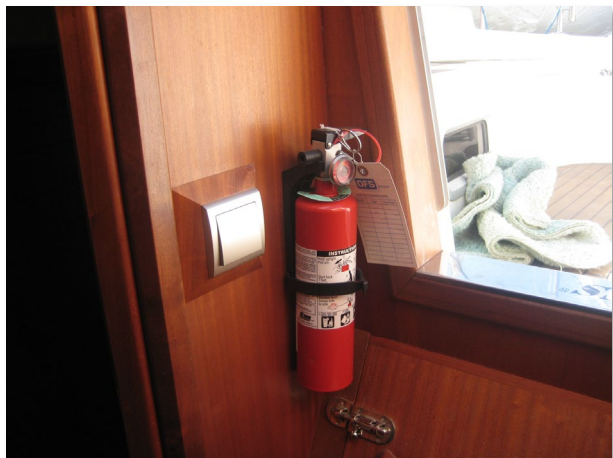
FIGURE 49 – PORTABLE FIRE EXTINGUISHER AT COMPANIONWAY

No carbon monoxide or smoke detectors sighted onboard. No high water alarm sighted onboard. Engine warning system alarm not tested. Portable fire extinguishers mounted, gauge shows fully charged.
