Condition & Valuation Marine Survey Report of

1987 Carver 32 Montego

Timothy J. S. Martin

SAMS Accredited Marine Surveyor® #1360

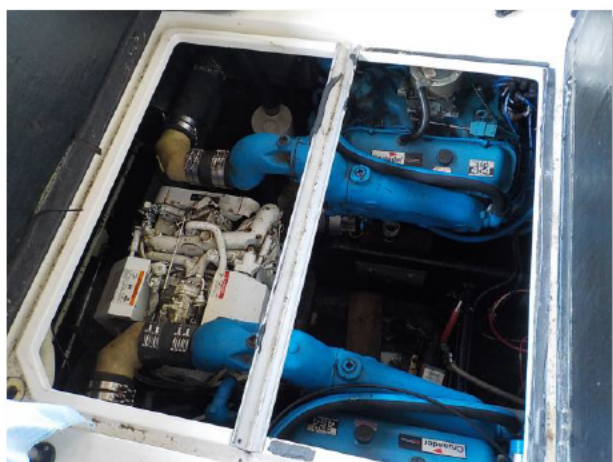
FIGURE 15 - MAIN ENGINES BELOW AFT DECK

Engine(s) appeared serviceable during the survey inspection. Nonetheless, a full mechanical inspection was not undertaken as a part of this survey. Engine(s) appeared securely installed to engine beds astern. Drive belts appeared to be intact, serviceable and properly tensioned. Flame arrestor(s) fitted as required. There were no fuel, oil, cooling or exhaust leaks found where components were accessible for inspection.

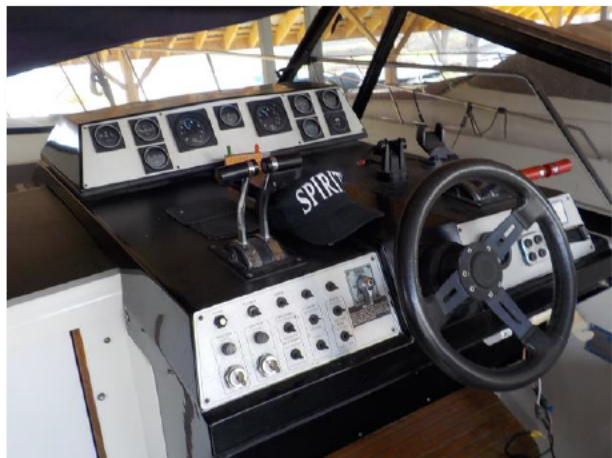
FIGURE 17 – CONTROLS AT HELM

Shift/throttle controls presented with smooth operation throughout operating range. Gauges were not tested for accuracy as part of this survey,

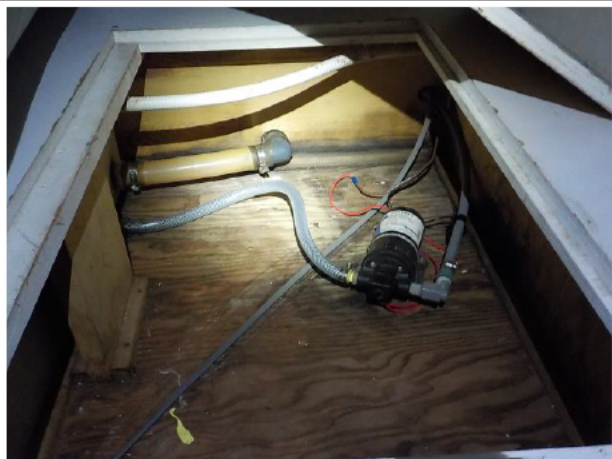
FIGURE 19 - WATER TANK AND PUMP BELOW AFT BERTH

Potable water tank(s), lines and fittings appeared securely installed to the vessel, serviceable and without visible leaks, where accessible for inspection. Water system pressure pump was not powered up. System found to be partially disassembled/decommissioned for off-season storage/service. The water heater appeared intact and undamaged, with no visible leaks from fittings and no standing water around the base of the tank.

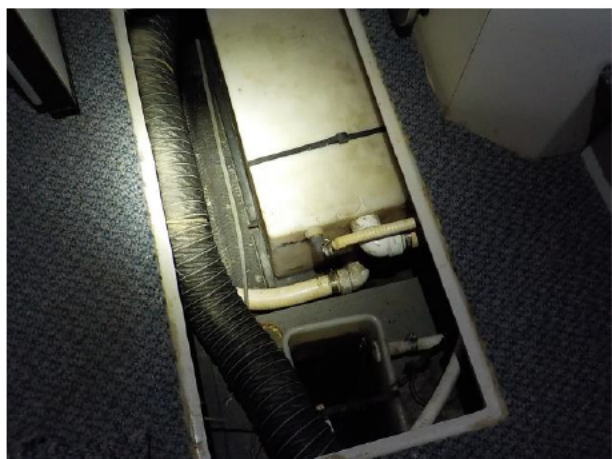
FIGURE 21 - HOLDING TANK BELOW CABIN SOLE

Holding tank, lines, fittings and fixtures appeared intact, securely fastened and without visible leaks, where accessible for inspection. Sanitation hoses and fittings appeared serviceable where accessible for inspection. Not powered up. Overboard discharge appeared compliant with U.S./Canadian regulations.

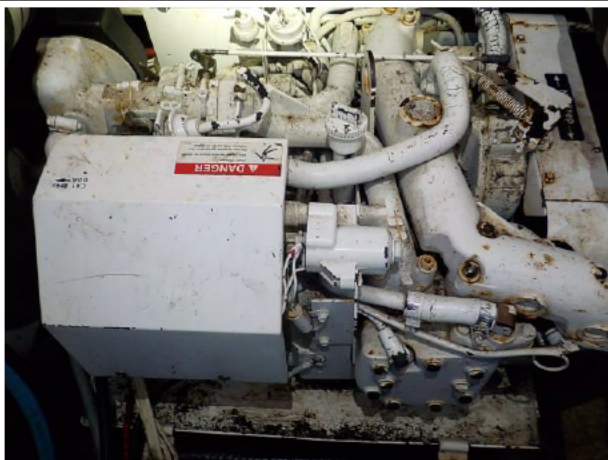
FIGURE 27 - GENERATOR

No access to generator manufacturer label due to location of installation. Generator appeared serviceable. Installation appeared to be secure and compliant. No oil, coolant, fuel, or exhaust leaks were sighted on visual inspection of the generator and related components. Generator not started with vessel out of the water.

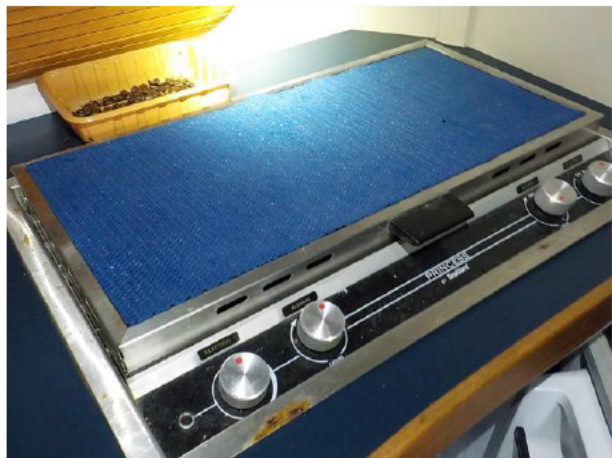
FIGURE 29 – RANGE FITTED IN GALLEY

Cooking appliances sighted onboard appeared serviceable.
