**Condition & Valuation Marine Survey Report of**

██████████  
**1982 Tayana Vancouver 42**

Sophie Foster, M.Eng  
Staff Surveyor/Naval Architect  
Transport Canada Appointed Tonnage Measurer <24m

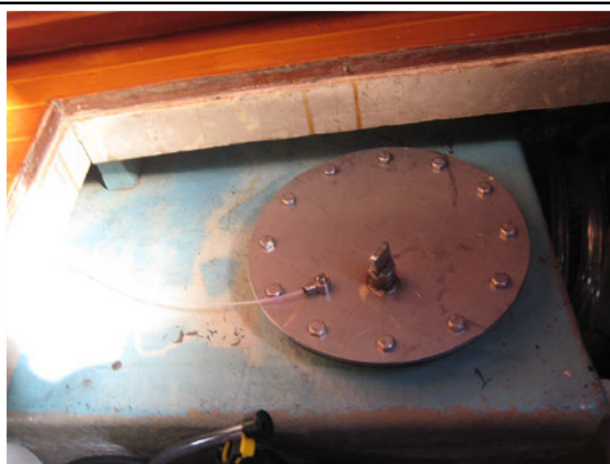
FIGURE 25 – STARBOARD FUEL TANK

Very limited access to fuel tanks due to configuration of installations. Tanks appeared to be intact and securely fastened to the vessel. No tank labels sighted. No leaks were sighted at the tanks or tank fittings. Deck fill fittings appeared to be intact, securely fastened and serviceable. Deck fill fittings are not marked with fuel type. Venting appeared intact where accessible for inspection. Deck fill grounding not sighted due to limited access. Fuel tank grounding appeared compliant where accessible for inspection. Fuel valves appeared serviceable and without leaks or weeping at valve bodies or fittings. Fuel valves were cycled and confirmed operational. Fuel filters secured to the vessel and engine and appeared serviceable. No leaks sighted at fuel filters or related fittings. Compliant hoses sighted for fuel fill, vent and supply, dates not visible. Fuel hoses appeared intact and serviceable where accessible for inspection. Double hose clamps of sufficient size are installed on accessible fuel fill hose fittings. Engine fuel pumps not sighted. Fuel level gauge appeared serviceable but was not tested for accuracy as part of this survey.

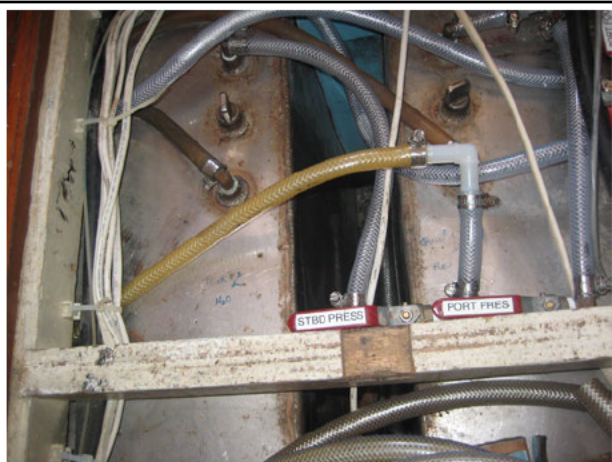
FIGURE 27 - FRESH WATER TANKS

Very limited access to the water system pressure pump due to location of installation. Label not accessible for inspection. Very limited access to fresh water tanks due to configuration of installations. Potable water tanks, lines and fittings appeared securely installed to the vessel, serviceable and without visible leaks, where accessible for inspection. Water system pressure pump powered up briefly and sounded operational but not tested with water system decommissioned. The water heater appeared intact and undamaged, with no visible leaks from fittings and no standing water around the base of the tank. Water heater not tested. Water filtration system(s) were not tested as a part of this survey.

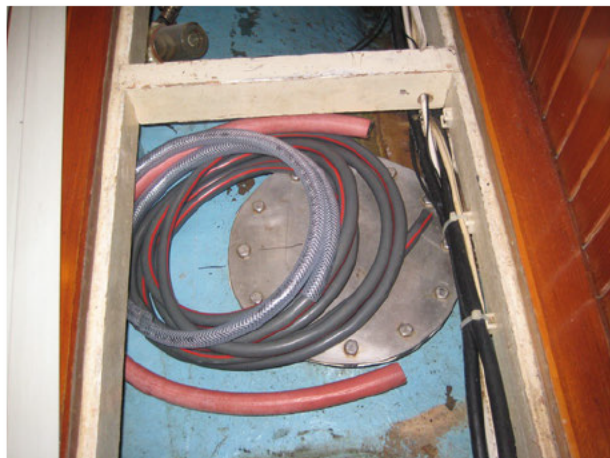
FIGURE 29 – HOLDING TANKS

Holding tank, pumps, lines, fittings and fixtures appeared intact, securely fastened and without visible leaks, where accessible for inspection. Sanitation hoses and fittings appeared serviceable where accessible for inspection. Owner reported macerator pump is inoperable and has not been used in some time. Holding tank appeared to be plumbed to permit discharge of sewage overboard.

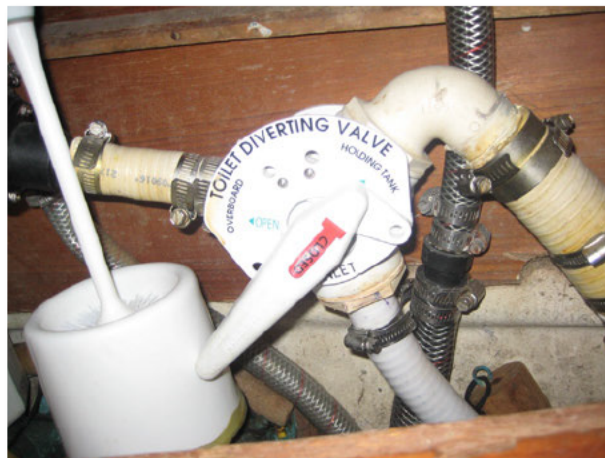
FIGURE 30 – Y-VALVE OR DIVERTING WASTE TO TANK OR OVERBOARD

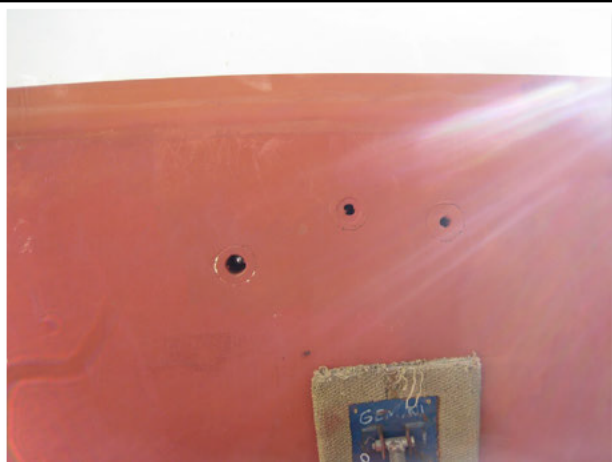
FIGURE 33 – THROUGH-HULLS PORT SIDE

Topsides through-hull fittings appeared intact and securely fastened to the vessel. Through-hull fittings below the waterline appeared intact and securely fastened to the vessel. Through-hulls observed to be without external flanges. Seacocks are fitted on through-hull fittings below the waterline, where accessible for inspection. Seacocks cycled and found to be serviceable at time of inspection. Bungs are provided at all accessible through-hulls below the waterline. Hose clamps appeared securely installed where accessible for inspection.

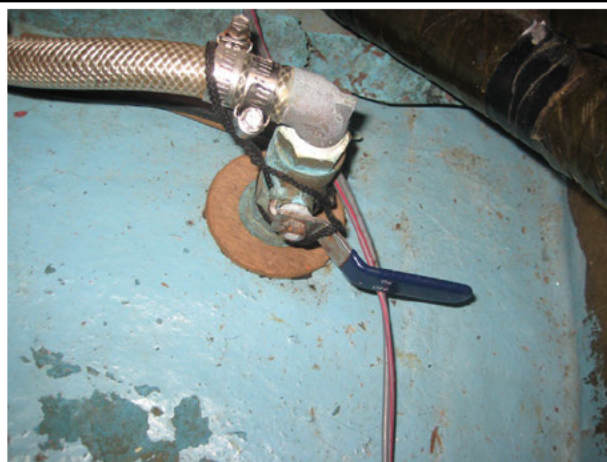
FIGURE 34 – SEA COCK FITTED TO THROUGH-HULL

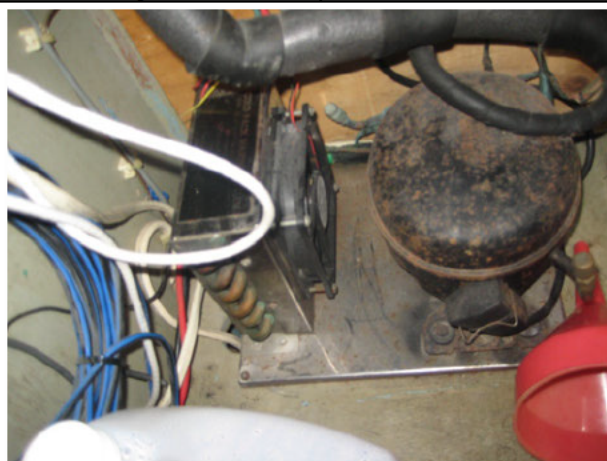
FIGURE 40 - COMPRESSOR UNIT

Refrigeration appliances appear to be intact and serviceable. Refrigeration units appear to be properly secured to the vessel structure. Refrigeration appliances were powered up and confirmed operational on all applicable power sources.

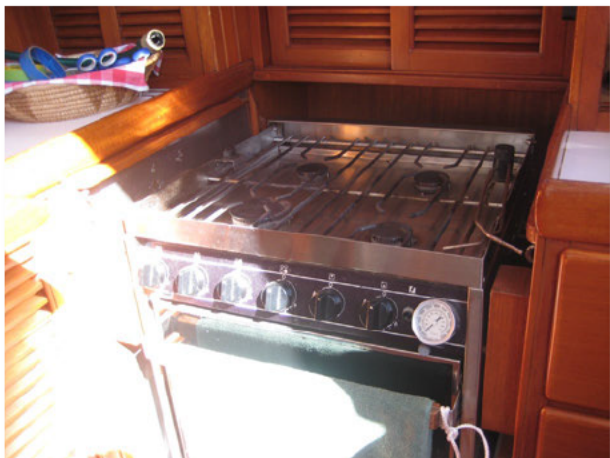
FIGURE 41 – RANGE TOP AND OVEN IN GALLEY

Cooking appliances sighted onboard appeared serviceable. Cooking appliances stowed/secured as required for crew safety while underway. Not tested as part of this survey.

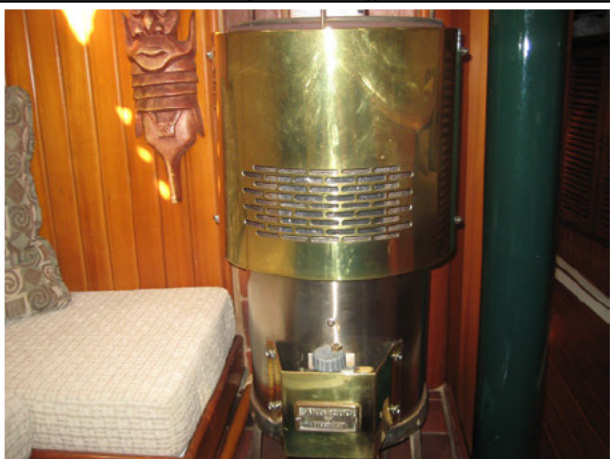
FIGURE 43 – DIESEL HEATER IN SALON

Diesel heater found onboard appeared serviceable but was not tested as part of this survey.

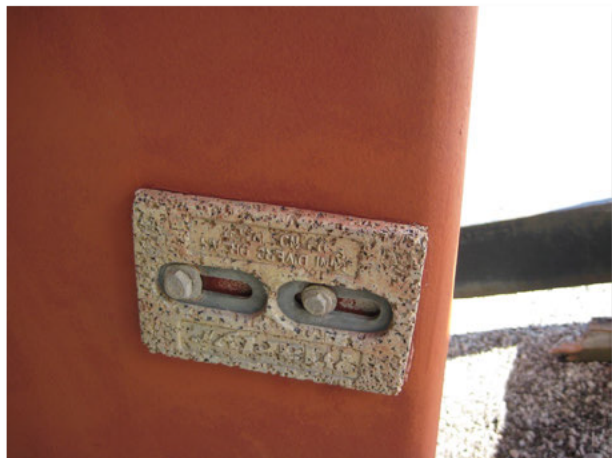
FIGURE 45 - PLATE ANODE ON KEEL

Anodes appeared to be securely installed and in serviceable condition. Metallic through-hulls below the waterline appeared to be bonded where accessible for inspection.

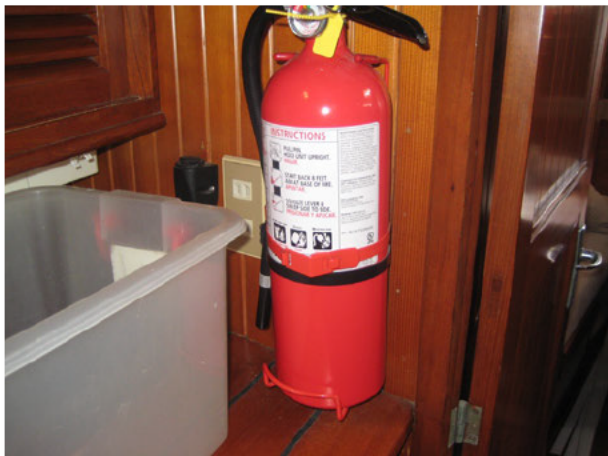
FIGURE 49 - PORTABLE FIRE EXTINGUISHER IN V-BERTH

Propane fume detector appeared serviceable. Unit tested via integral test function and reported audible confirmation tone. Engine warning system alarm confirmed operational with 'key on' power supplied. Individual alarms for low oil pressure, overheat and other connected sensors were not specifically tested as a part of this survey. High water alarm installed in engine space, with monitor at navigation table, powered up and confirmed operational. Portable fire extinguishers mounted, gauges show mostly fully charged.

Fire extinguisher should be recharged or replaced, in order to comply with Section 5(2) of the Small Vessel Regulations.
