**Condition & Valuation Marine Survey Report of**

**1988 Kha Shing Overseas 40**

Timothy J. S. Martin

SAMS Accredited Marine Surveyor® #1360

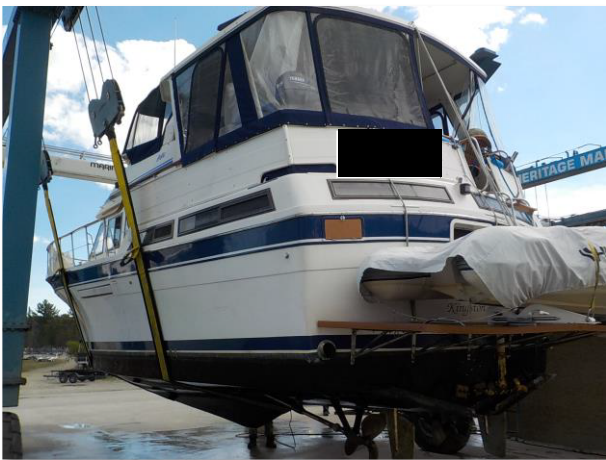
FIGURE 3 - PORT STERN VIEW

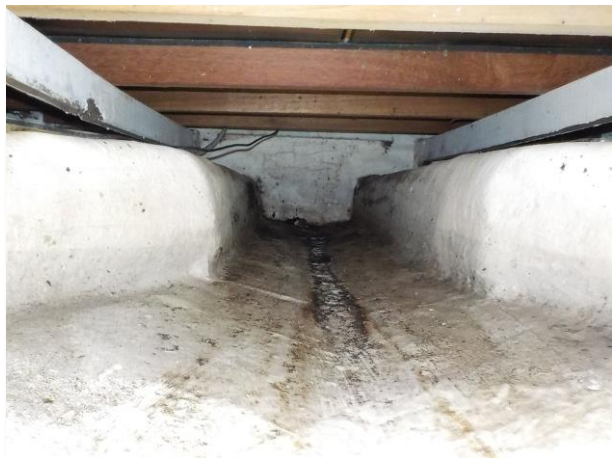
The hull is constructed of moulded FRP. Accessible spans of the hull laminate below decks appeared to be solid laminate without cored areas. Ablative bottom paint appeared in serviceable condition. Bottom appeared intact. No cracks observed. The subject vessel is fitted with a drift keel constructed of fibreglass. The keel appeared intact.

FIGURE 11 – HULL FRAMING BELOW AFT CABIN SOLE

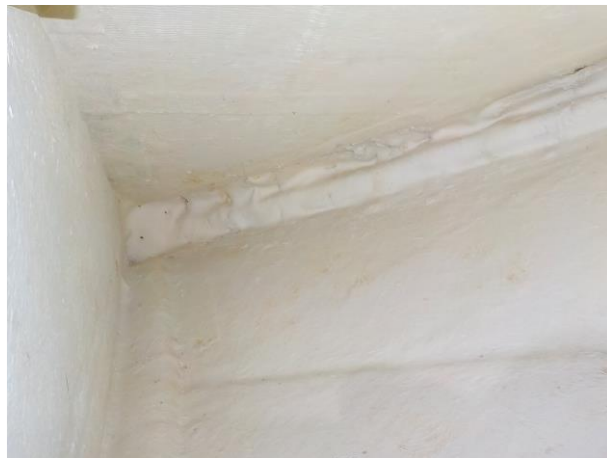
Limited access to the hull/deck joint due to vessel design. Access available only in the forepeak rode locker. The hull/deck joint appears to be of a shoebox type, with the deck flange sitting outboard of the hull flange, mechanically fastened and bonded. An external plastic rub rail is fitted, with a stainless insert, around the perimeter of the hull/deck joint. The hull/deck joint appeared intact and without visible signs of water seepage where accessible for inspection. The rub rail appeared to be intact and securely fastened.

FIGURE 12 – HULL/DECK JOINT AND BULKHEAD IN FOREPEAK

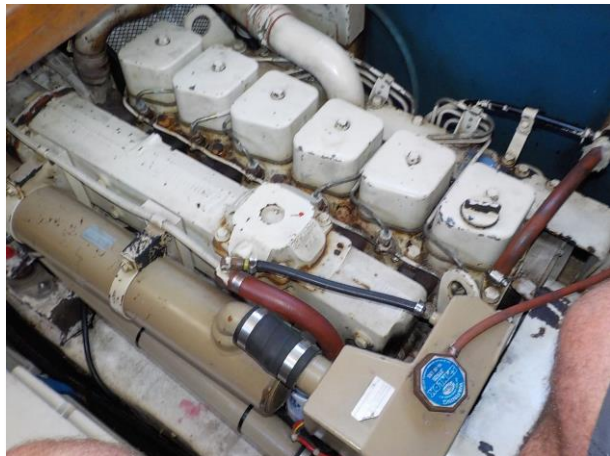
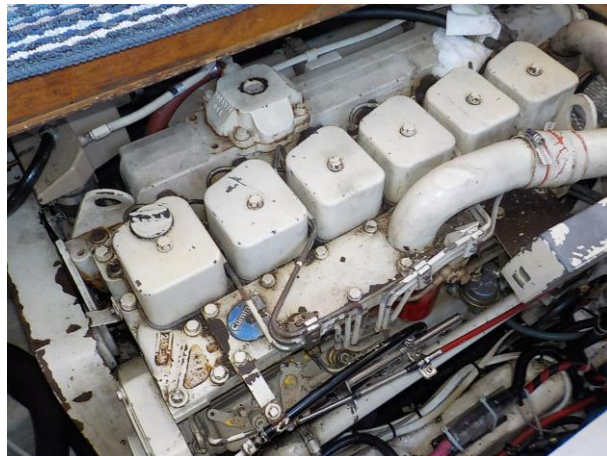
FIGURE 13 – PORT MAIN ENGINE

FIGURE 14 – STARBOARD MAIN ENGINE

Engine(s) appeared serviceable during the survey inspection. Nonetheless, a full mechanical inspection was not undertaken as a part of this survey. Engine(s) appeared securely installed to engine beds amidships. Machinery guards were observed to be in place as required. There were no oil or exhaust leaks found where components were accessible for inspection.

The engine(s) ran well during sea trial. Engine(s) started easily and without notable smoke during cold start-up. Idle speed appeared normal, vessel came up to cruising speed quickly under full power. Engine(s) performed well at wide open throttle and reached acceptable rpm during the sea trial. Engine synchronization was found to be audibly correct and confirmed with gauges while underway. No movement was observed at the engine mounts during a backdown test at sea trial. Thermal imaging showed no unusual high temperatures in the engine and exhaust system castings during sea trial.

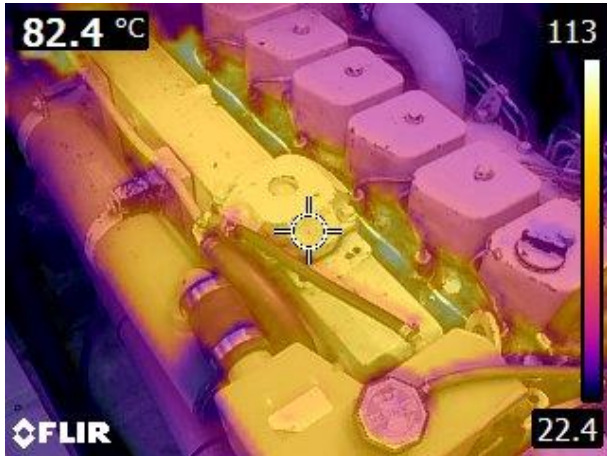
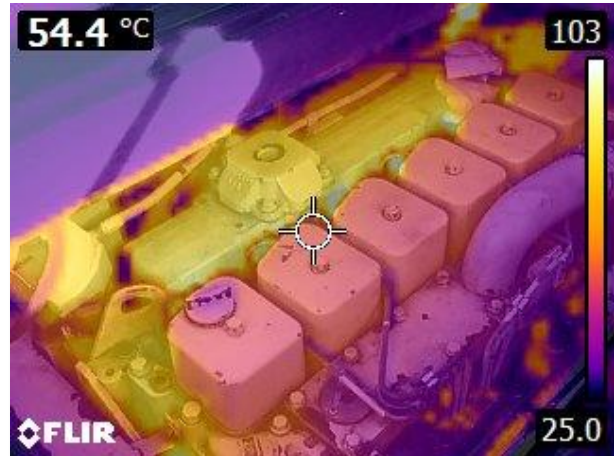
FIGURE 15 - THERMAL IMAGE OF PORT MAIN ENGINE

FIGURE 16 - THERMAL IMAGE OF STARBOARD MAIN ENGINE

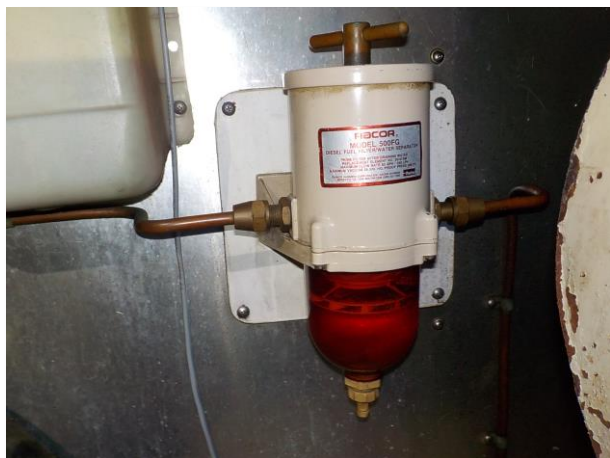
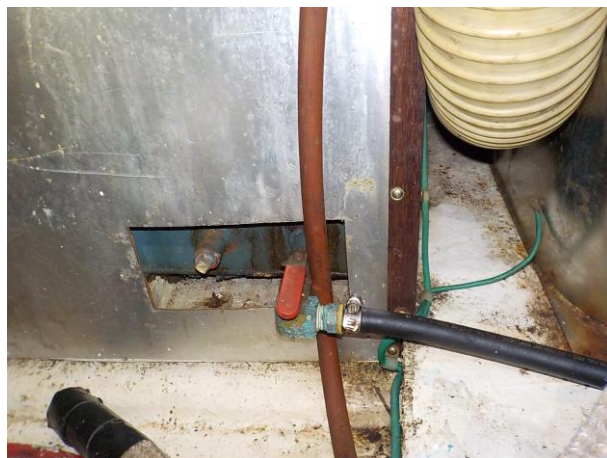
FIGURE 19 – FUEL FILTER IN ENGINE SPACE

FIGURE 20 – TANK ENCLOSURE WITH BALL VALVE

Tank(s) appeared to be intact and securely fastened to the vessel. Tank label(s) not sighted. No leaks were sighted at the tank(s) or tank fittings. Deck fill fitting(s) appeared to be intact, securely fastened and serviceable. Venting appeared intact where accessible for inspection. Deck fill grounding not sighted due to limited access. Fuel tank grounding appeared compliant where accessible for inspection. Fuel valves appeared serviceable and without leaks or weeping at valve bodies or fittings. Fuel valves were cycled and confirmed operational. Fuel filter(s) secured to the vessel and appeared serviceable. No leaks sighted at fuel filter(s) or related fittings. Diesel in the sight bowls appeared clean and free from excessive debris. Fuel hose markings not accessible for inspection on some of the fuel hoses. Some of the fuel hoses observed onboard appeared to be compliant and correctly marked. Fuel hoses appeared intact where accessible for inspection. Double hose clamps of sufficient size are installed on accessible fuel fill hose fittings. No leaks sighted from fuel hoses or related fittings while underway during sea trial. No fuel transfer pump sighted onboard. Fuel pump(s) appeared to be original equipment and serviceable. No active leaks sighted from fuel pump on engines while underway during sea trial. Fuel level gauge(s) appeared serviceable but were not tested for accuracy as part of this survey. Floscan fuel flow metering system fitted alongside both main engines in the engine space. System appeared serviceable and accurate during sea trial.

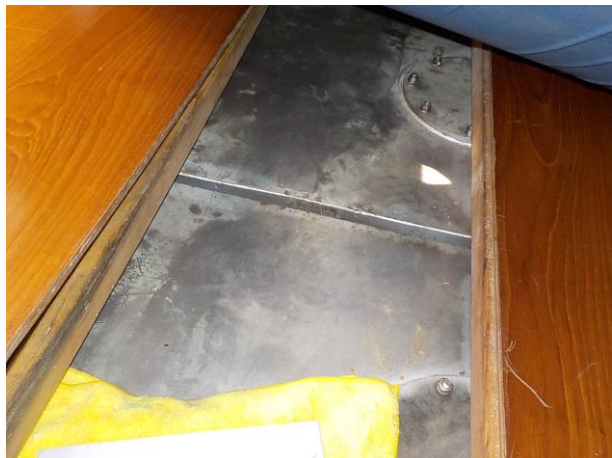
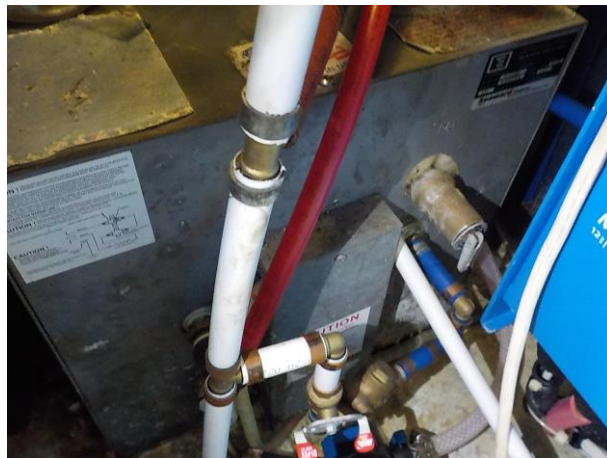
FIGURE 21 – DUAL TANKS FITTED BELOW AFT BERTH

FIGURE 22 – HOT WATER TANK IN ENGINE SPACE

Potable water tank(s), lines and fittings appeared securely installed to the vessel, serviceable and without visible leaks, where accessible for inspection. Water system pressure pump powered up briefly but not tested with water system decommissioned. The water heater appeared intact and undamaged, with no visible leaks from fittings and no standing water around the base of the tank. The water heater was not powered up or tested with the water system decommissioned. Water filtration system(s) were not tested as a part of this survey.

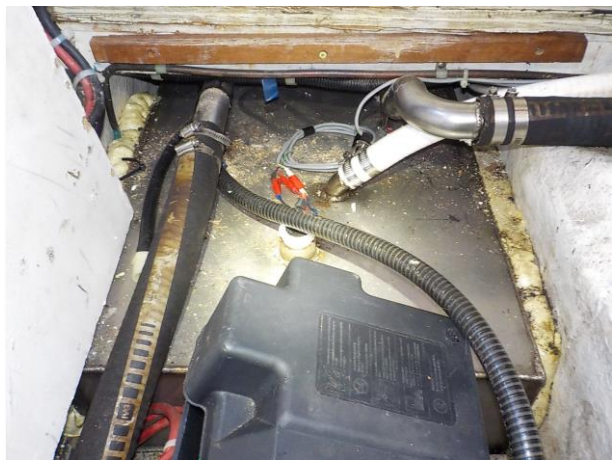
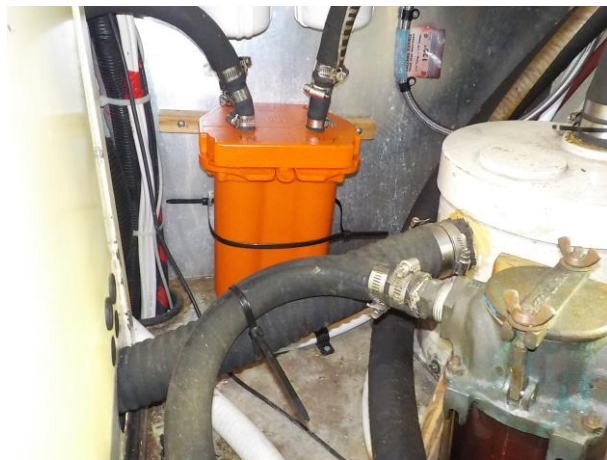
FIGURE 23 – HOLDING TANK IN ENGINE SPACE

FIGURE 24 – HOLDING TANK VENT FILTER

Holding tank, pumps, lines, fittings and fixtures appeared intact, securely fastened and without visible leaks, where accessible for inspection. Sanitation hoses and fittings appeared serviceable where accessible for inspection. System found to be decommissioned for off-season storage and was therefore not tested.

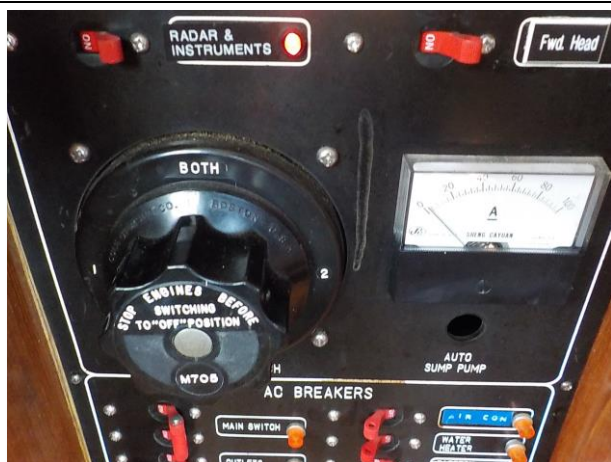
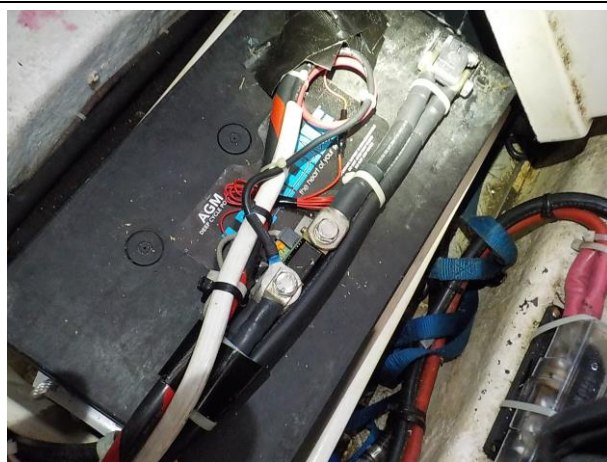
FIGURE 25 – MAIN BATTERY DISCONNECT IN SALON DC PANEL BOARD      FIGURE 26 – 8D BATTERY IN ENGINE SPACE

No ready access to back of panel for inspection (disassembly of cabinetry required to access, which is beyond the scope of this survey). Battery master disconnect switch(es) and DC panel boards appeared to be intact and compliant, where accessible for inspection. Battery connections appeared clean and secure. Proper electrolyte containment observed. Positive (+) terminal(s) appeared properly insulated. Very limited access to large spans of DC wiring harnesses installed to cable races throughout the vessel. Wiring insulation, connections and related fixtures appeared mostly compliant and in serviceable condition where accessible for inspection. DC power appeared consistent on relevant tested circuits while underway during sea trial. Choose a building block. Alternator(s) not thoroughly tested for output as a part of this survey, however, increased voltage was observed with engine(s) running during sea trial. Solar panel(s), controller and connections appeared securely installed and mostly compliant, where accessed for inspection.

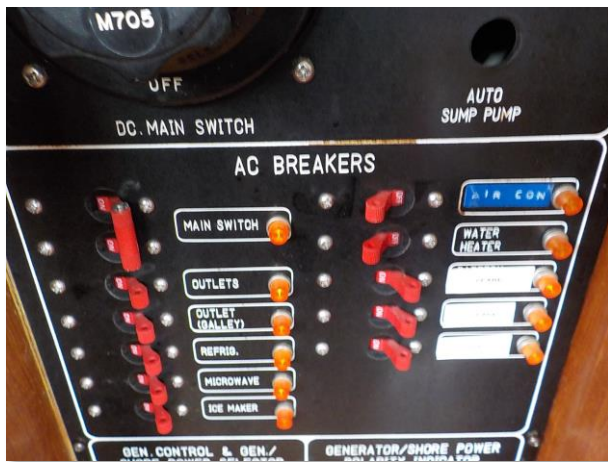
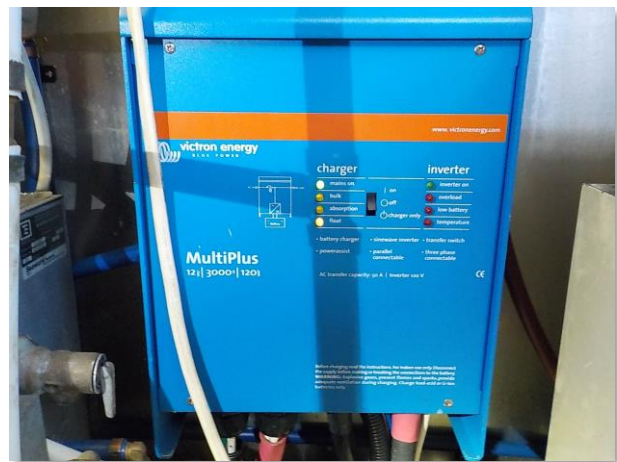
FIGURE 27 – MAIN AC PANEL BOARD IN SALON

FIGURE 28 – CHARGER/INVERTER IN ENGINE SPACE

No ready access to back of panel for inspection (disassembly of cabinetry required to access, which is beyond the scope of this survey). Panel board installation appeared compliant and serviceable, where accessible for inspection. Receptacles appeared securely installed in approved junction boxes and serviceable. GFCI receptacles tested and found to be operational. Very limited access to large spans of AC wiring harnesses installed to cable races throughout the vessel. AC wiring insulation, connections and fixtures appeared mostly compliant and in serviceable condition where accessible for inspection. Battery charger/inverter appeared securely installed and serviceable. Unit appeared to be mostly correctly installed, with secure connections and sufficient, suitable overcurrent protection. Powered up and appeared operational.

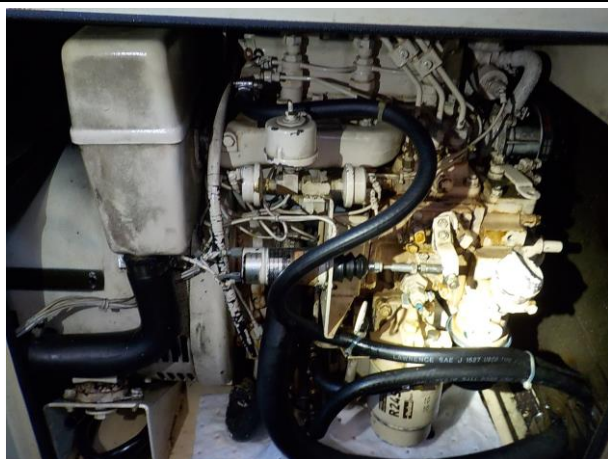
FIGURE 29 - GENERATOR INSTALLATION IN ENGINE SPACE

No access to generator manufacturer label due to location of installation. Generator appeared serviceable. Installation appeared to be secure and compliant. No oil, coolant, fuel, or exhaust leaks were sighted on visual inspection of the generator and related components. Generator not started, as the current owner had already winterized the unit ready for off-season storage.

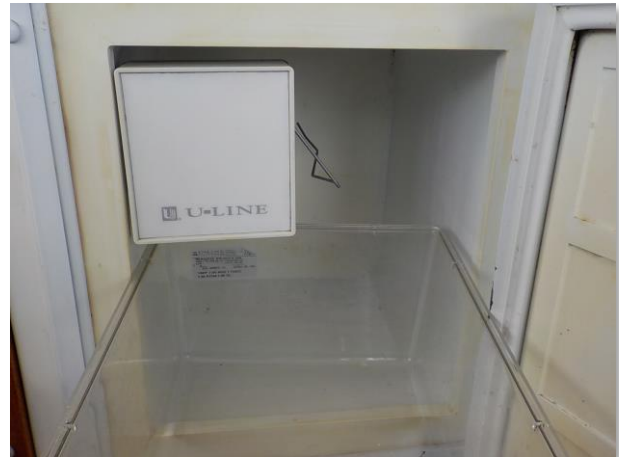
- Problems with reliability of wind speed/direction instrumentation
- Problems with reliability of the Navman depth/speed display at the lower helm station
- Problems with reliability of the ice maker at the aft deck
- Problems with effectiveness of the externally mounted stern thruster and, more recently the stern thruster failed to operate and has been professionally diagnosed as having a seized motor

FIGURE 32 – AFT DECK ICE MAKER

Refrigeration appliances appear to be intact and serviceable. Refrigeration units appear to be properly secured to the vessel structure. Galley fridge powered up and confirmed operational on all applicable power sources. Ice maker at aft deck was not tested.

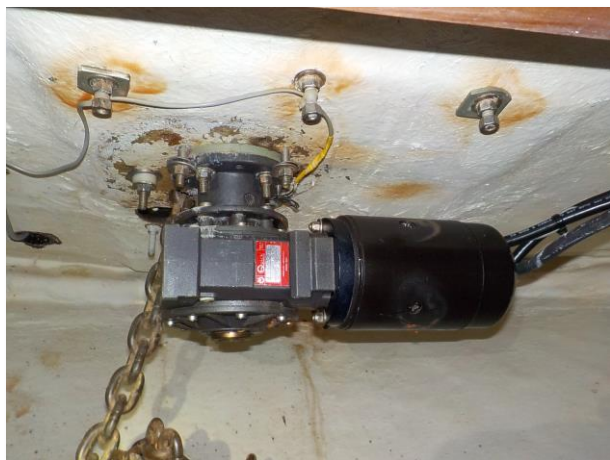
FIGURE 37 – WINDLASS IN FOREPEAK LOCKER

Fenders and mooring lines appeared serviceable. Anchor appeared serviceable. Chain/rode observed in forepeak rode locker, appeared sufficient for vessel and serviceable, but anchor chain/rode was not let out for detailed inspection due to the constraints of the location of inspection. The windlass appeared serviceable, with tidy wiring in the rode locker. Powered up and confirmed operational.
