Condition & Valuation Marine Survey Report of

2014 Tes 28 Magnam

Sophie Foster, M.Eng
Staff Surveyor/Naval Architect
Transport Canada Appointed Tonnage Measurer <24m

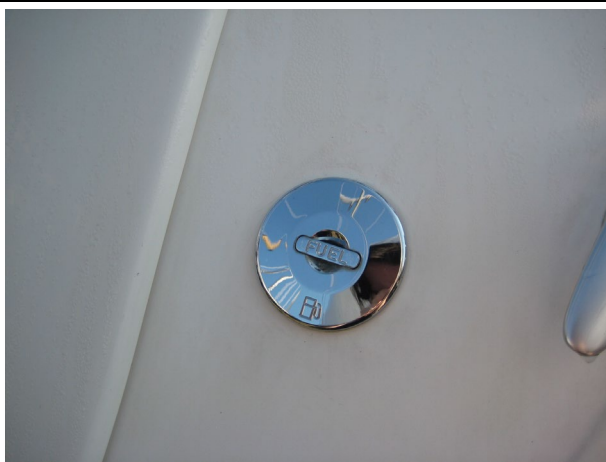
FIGURE 26 – DECK FILL FITTING AT TRANSOM

Tank appeared to be intact and securely fastened to the vessel. Tank label observed and appeared to be compliant. It was noted that the fuel tank is labelled gasoline but is reported to be the original installation by the manufacturer. No leaks were sighted at the tank or tank fittings. Deck fill fitting appeared to be intact, securely fastened and serviceable. Venting appeared intact where accessible for inspection. Plastic fuel tank does not require grounding. No deck fill grounding sighted. Fuel valves appeared serviceable and without leaks or weeping at valve bodies or fittings. Fuel valves were cycled and confirmed operational. Fuel filters secured to the vessel and appeared serviceable. No leaks sighted at fuel filters or related fittings. Compliant hoses sighted for fuel fill, vent and supply, no dates sighted. Fuel hoses appeared intact and serviceable where

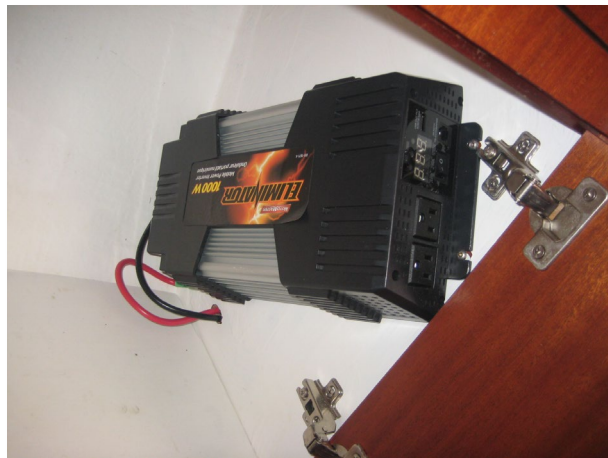
FIGURE 42 - INVERTER

Panel board installation appeared compliant and serviceable, where accessible for inspection. Receptacles appeared securely installed in approved junction boxes and serviceable. Very limited access to large spans of AC wiring harnesses installed to cable races throughout the vessel. AC wiring insulation, connections and fixtures appeared mostly compliant and in serviceable condition where accessible for inspection. AC power appeared consistent on relevant tested circuits while underway during sea trial. Battery charger appeared securely installed and serviceable. Unit appeared to be mostly correctly installed, with secure connections and sufficient, suitable overcurrent protection. No case grounding wire sighted. Powered up and appeared operational. Inverter unit currently installed has not been designed for marine use. No overcurrent protection sighted at inverter DC power supply. No warning label sighted at main AC electrical distribution panel. No inverter control/status panel installed. No GFCI protection sighted at built-in receptacles. Inverter installation has been completed since date of manufacture and is considered by the attending surveyor as a modification to the vessel's electrical systems.

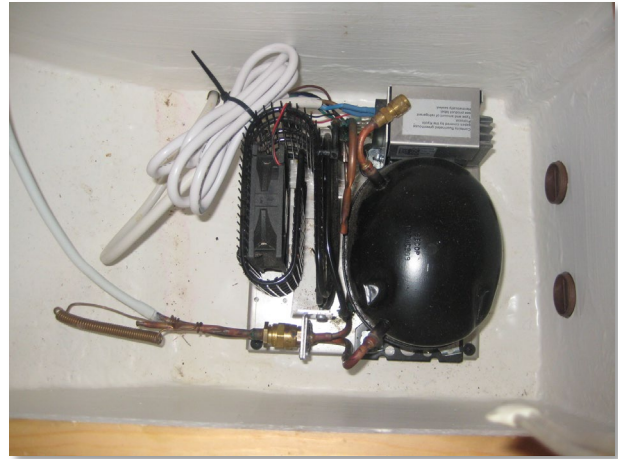
FIGURE 44 – COMPRESSOR UNIT FOR REFRIGERATOR

Refrigeration appliances appear to be intact and serviceable. Refrigeration units appear to be properly secured to the vessel structure. Refrigeration appliance powered up during dockside testing but did not appear to be cooling correctly.

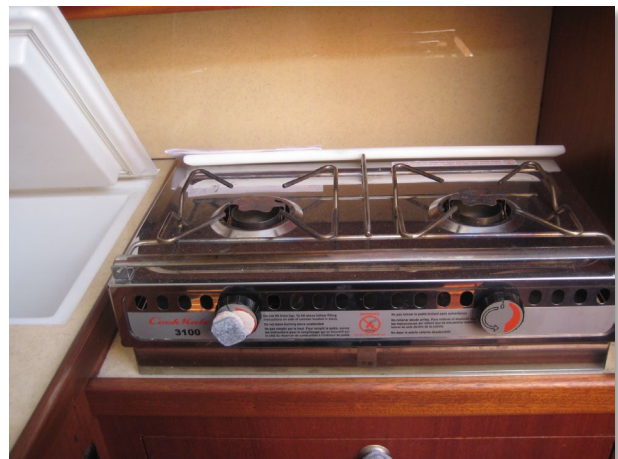
FIGURE 46 – RANGE TOP IN GALLEY

Cooking appliances sighted onboard appeared serviceable. Cooking appliances stowed/secured as required for crew safety while underway. Range top not tested during this survey.

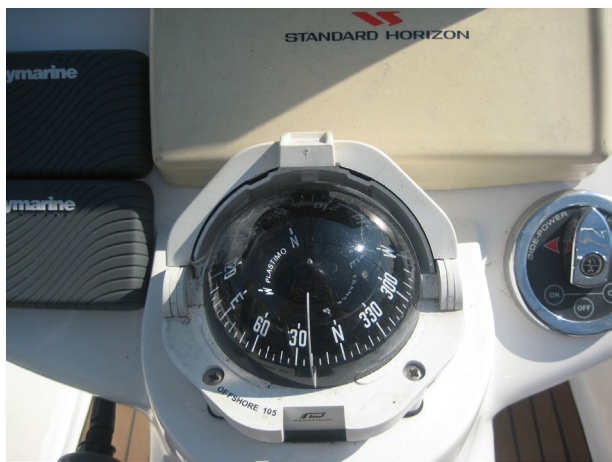
FIGURE 47 – COMPASS AT HELM

Navigation equipment powered up and confirmed mostly operational during sea trial. Helm displays appeared properly installed and serviceable. Cables and connections appeared secure and well-supported. Audio equipment appeared serviceable and securely fastened. Cable connections appeared to be correctly installed, serviceable and well supported. Powered up but appeared inoperable during dockside testing.

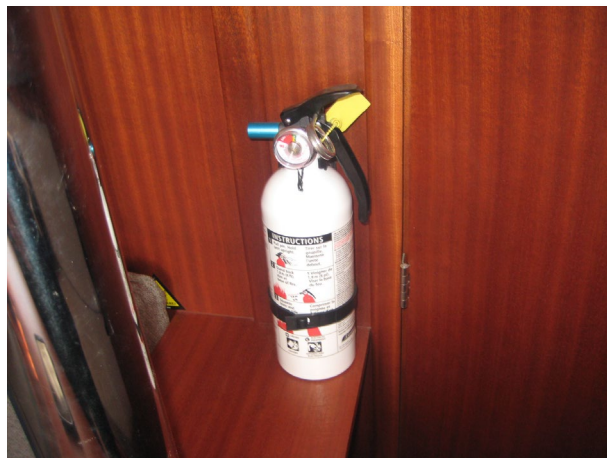
FIGURE 50 – PORTABLE FIRE EXTINGUISHER AT DINING TABLE

No carbon monoxide or smoke detectors sighted onboard. No high water alarm sighted onboard. Engine warning system alarm not tested. Portable fire extinguishers mounted, gauge shows fully charged.

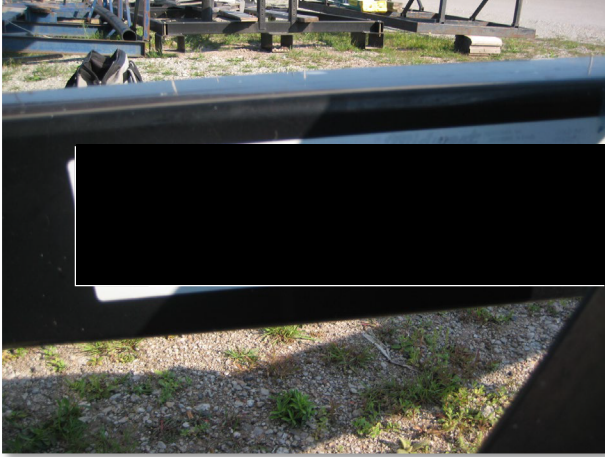
FIGURE 51 - TRAILER LOAD DECAL

The trailer has been included in this report for valuation purposes only, and the attending surveyor(s) cannot certify its condition or suitability for intended use.
